YOUR Inspection Report

123 Lake Front Road
Cottage Country, ON P1L 1L4

Monday, October 22, 2012

RE: Report No. 2179, v.2
123 Lake Front Road
Cottage Country, ON
P1L 1L4

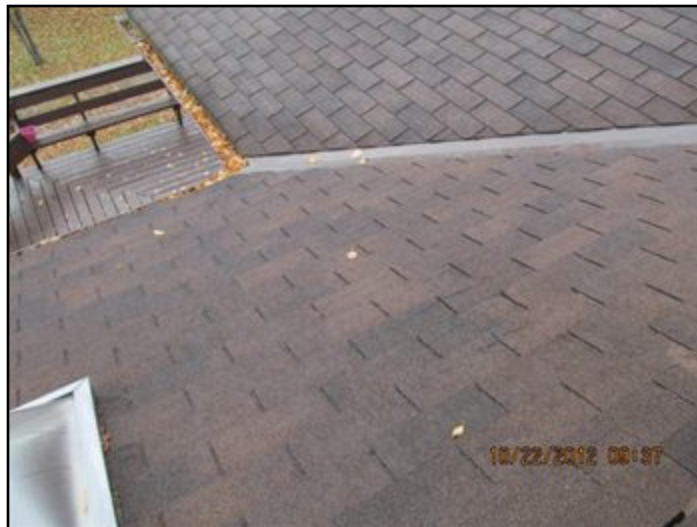
Condition: • [Cupping, curling, clawing](#)

Implication(s): Chance of water damage to contents, finishes and/or structure

Shingles showing wear

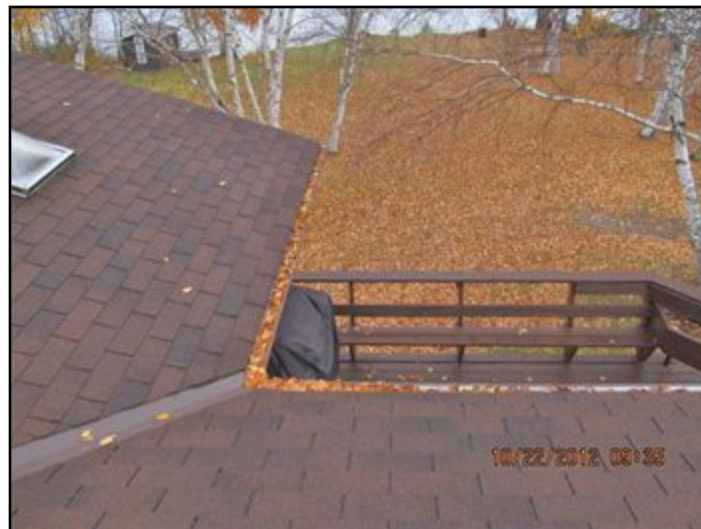
Condition: • [Clogged](#)

Gutters clogged with leaves

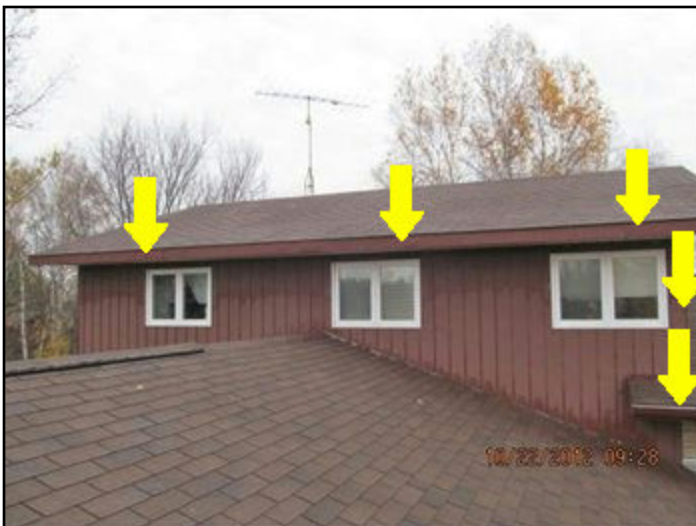
Condition: • [Missing](#)

Missing gutter & downspout at rear

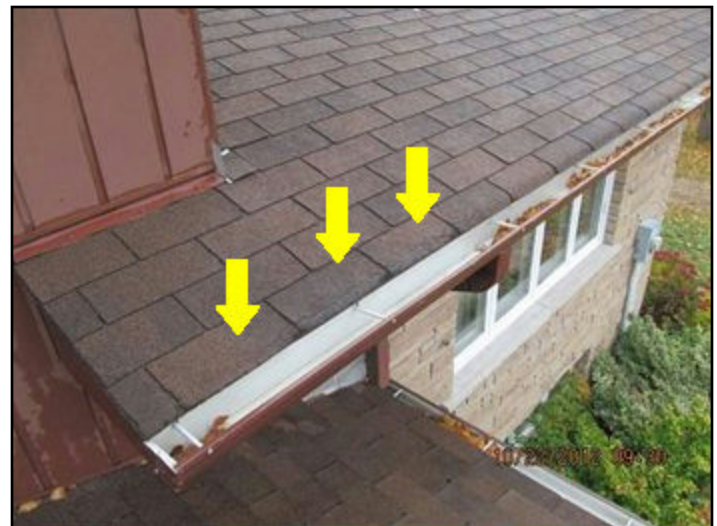
Shingles deteriorated

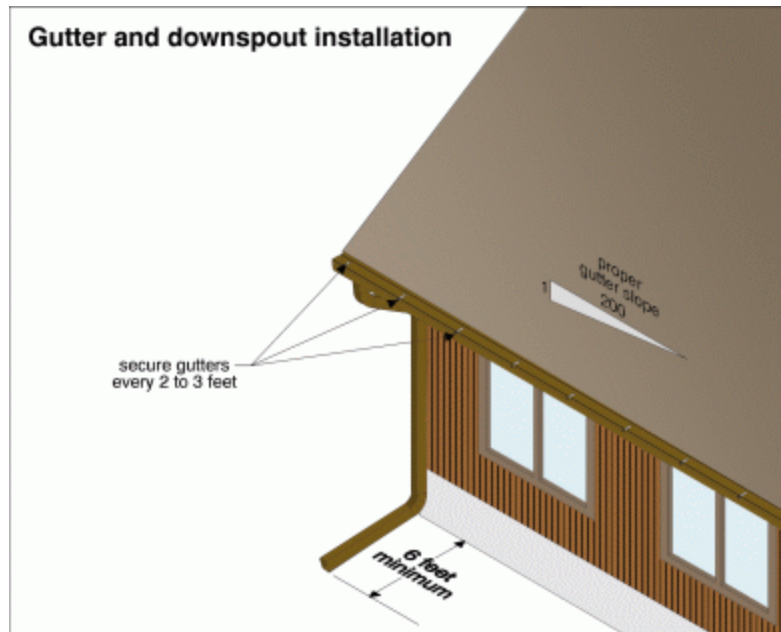
Condition: • [Downspouts end too close to building](#)

Downspout extension too short

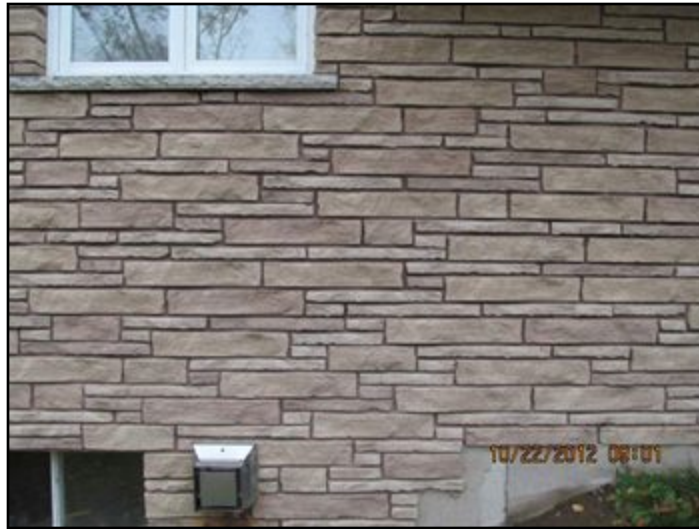
Condition: • [Cracked](#)

Cracking in brick facing

Task: Repair

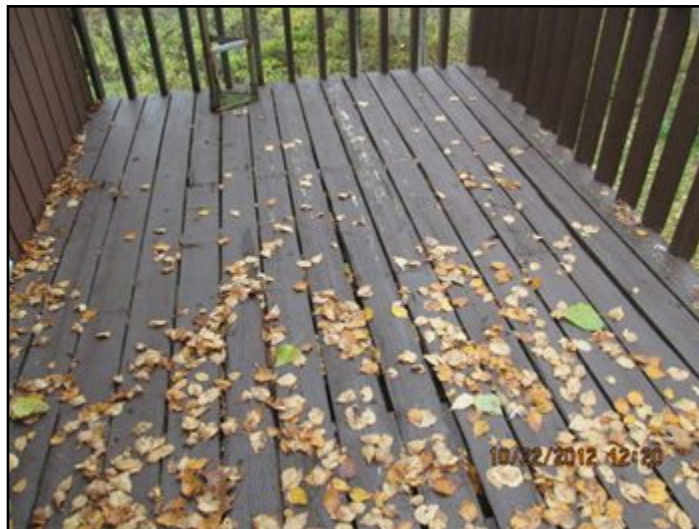
Condition: • [Rot](#)

Implication(s): Weakened structure | Chance of movement | Material deterioration

Deck boards showing age

Task: Repair or replace

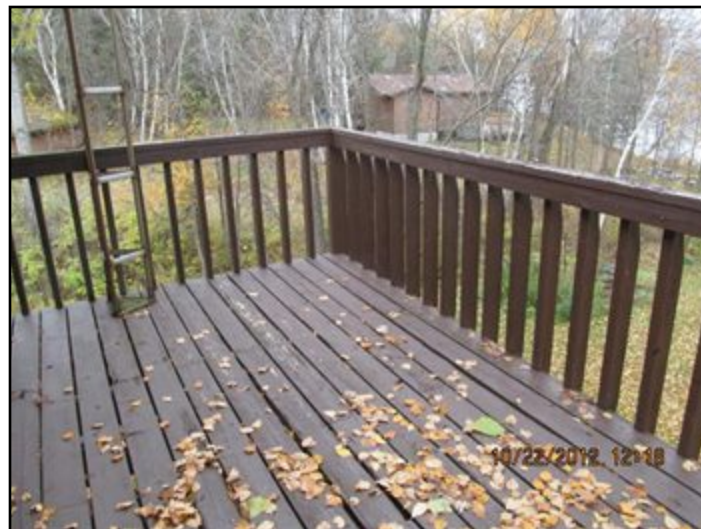
Condition: • [Too low](#)

Implication(s): Fall hazard

Upper deck railing too short

Task: Replace

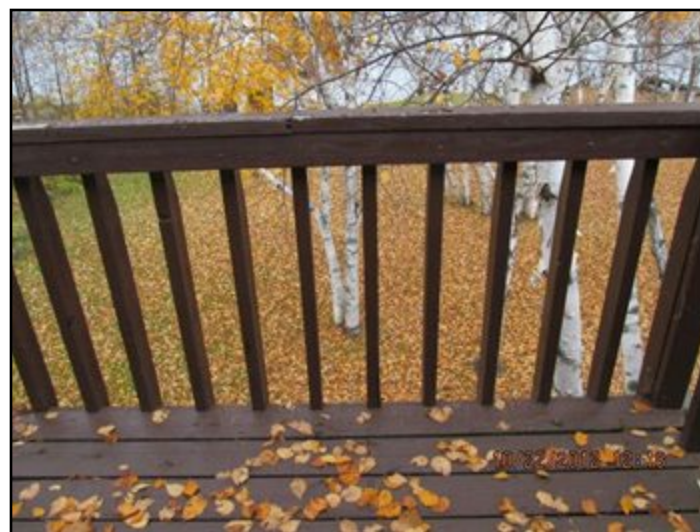
Condition: • [Spindles too far apart](#)

Implication(s): Fall hazard

Spindles spaced too far apart

Task: Replace

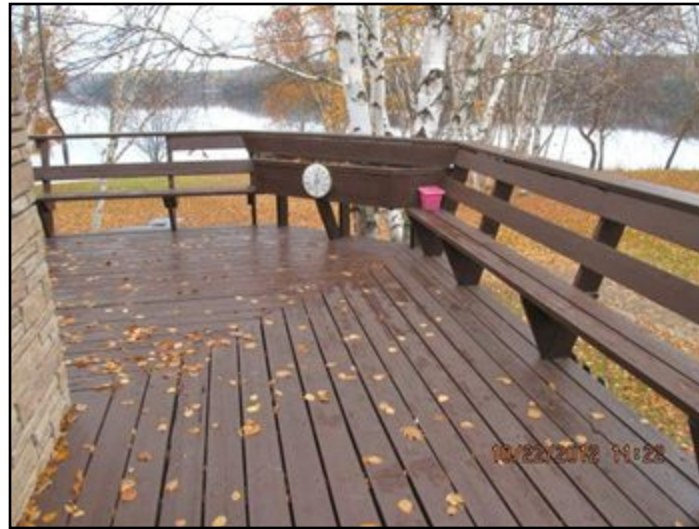
Condition: • [Spindles climbable](#)

Implication(s): Fall hazard

Deck railing climable

Task: Replace

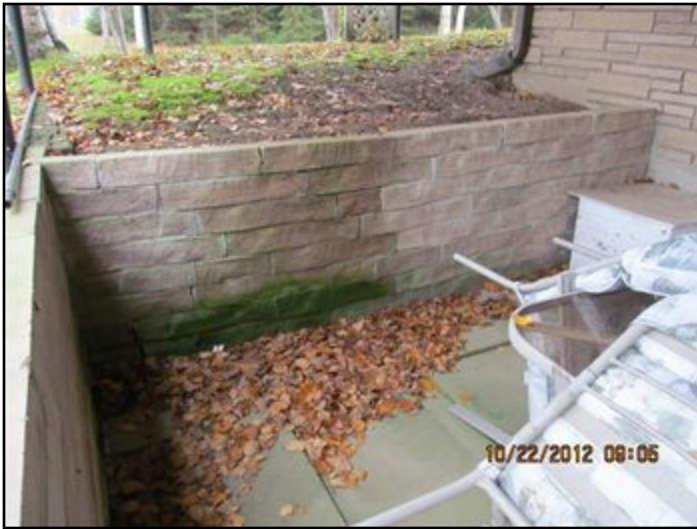
Condition: • [Bowing or bulging](#)

Wall bowing out

Task: Repair or replace

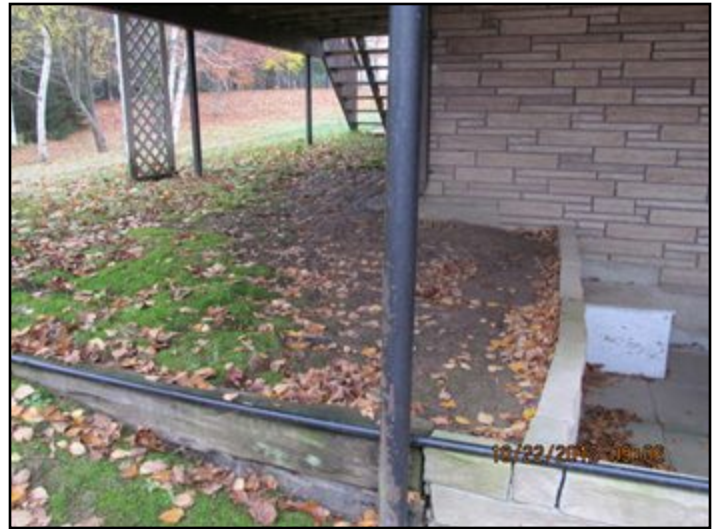
Grading towards wall

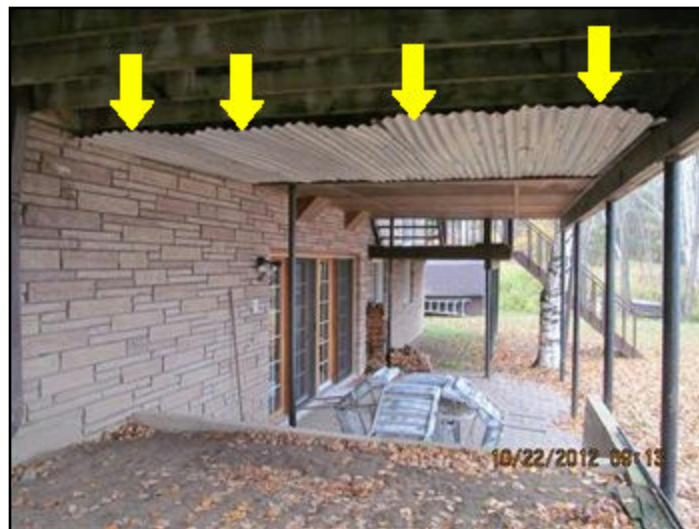
Plexi draining over wall

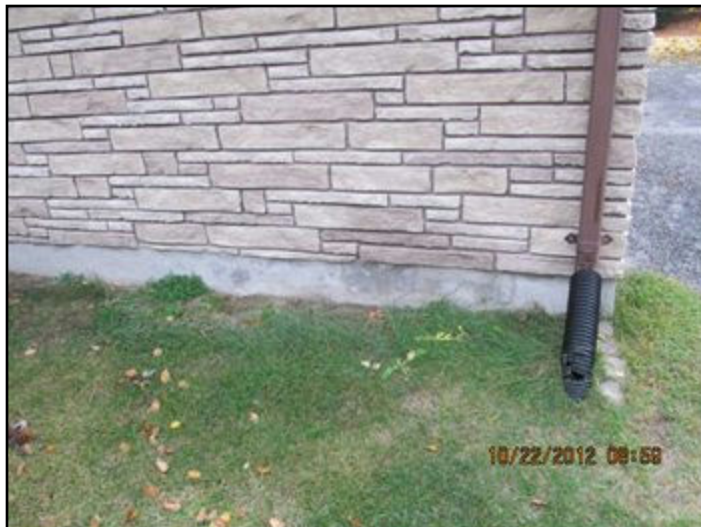
Condition: • Typical minor cracks

Small crack in garage foundation

Task: Monitor

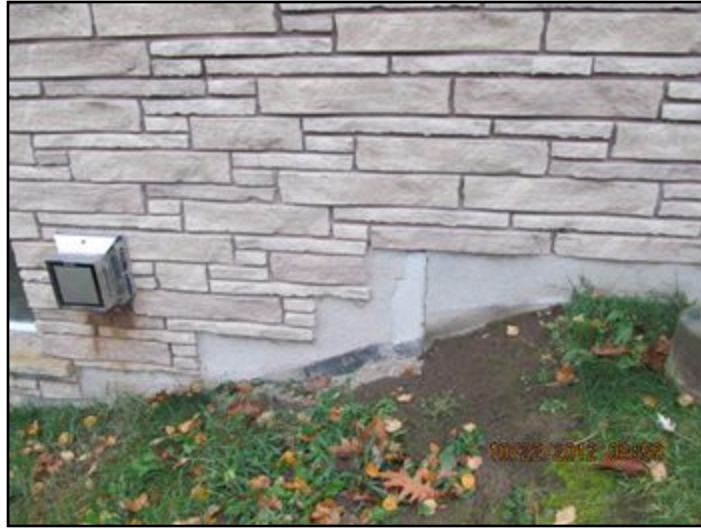
Condition: • [Parging damaged or missing](#)

Implication(s): Chance of damage to structure | Shortened life expectancy of material

Loose parging

Task: Repair

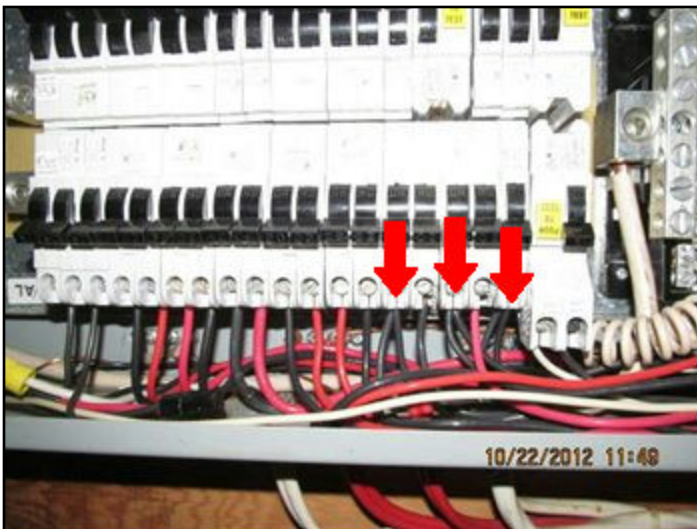
Condition: • [Double taps](#)

Implication(s): Fire hazard

Three double taps

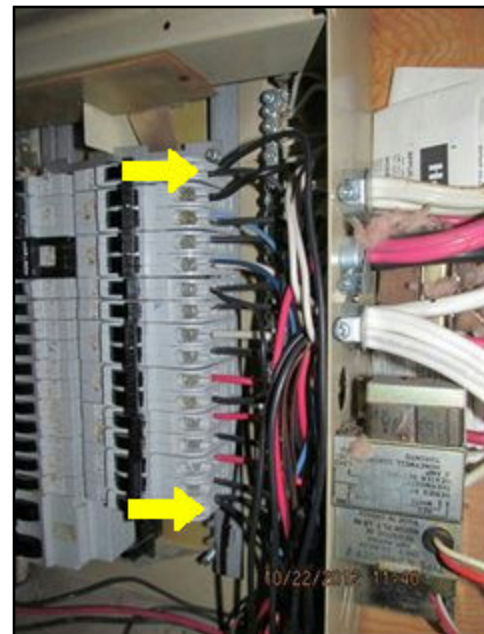
Two double taps

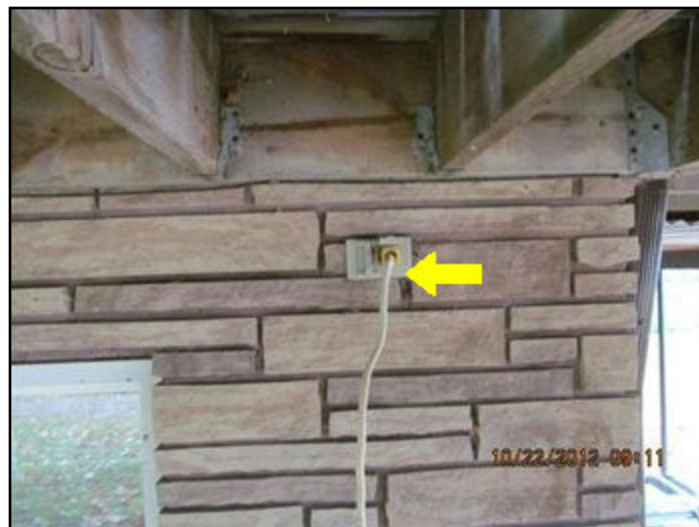
Condition: • [Permanent wiring used as extension cord](#)

Implication(s): Electric shock | Fire hazard

Permanent wire used as extension cord

Task: Correct

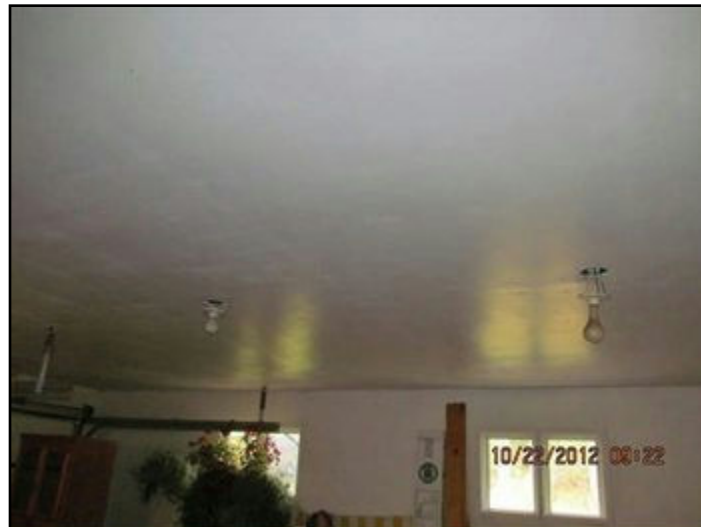
Condition: • [Loose](#)

Implication(s): Electric shock | Fire hazard

Lights loose in ceiling

Task: Repair

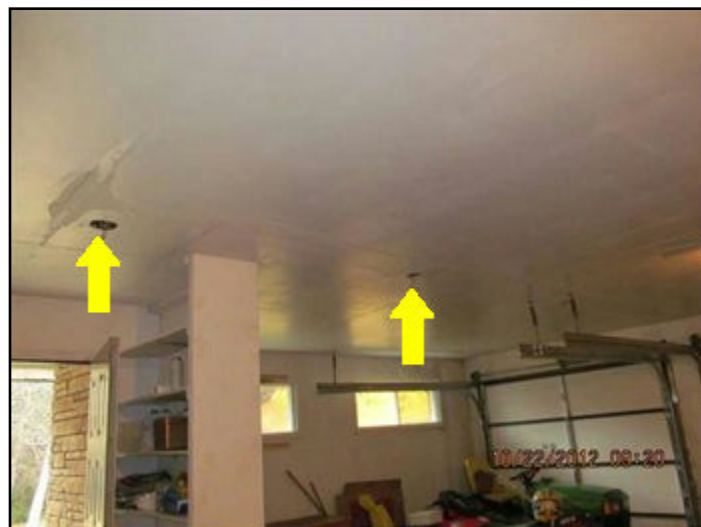
Condition: • [Missing](#)

Implication(s): Inadequate lighting

Lights missing

Task: Provide

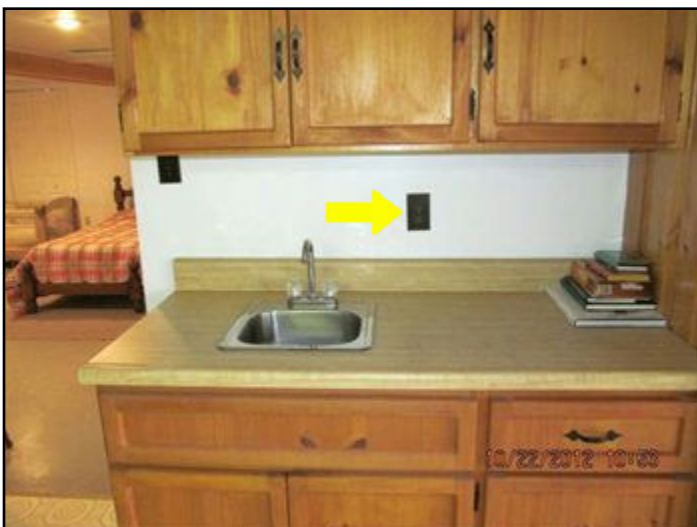
Condition: • [No GFI \(Ground Fault Interrupter\)](#)

Recommend GFI protected outlet here

Task: Replace

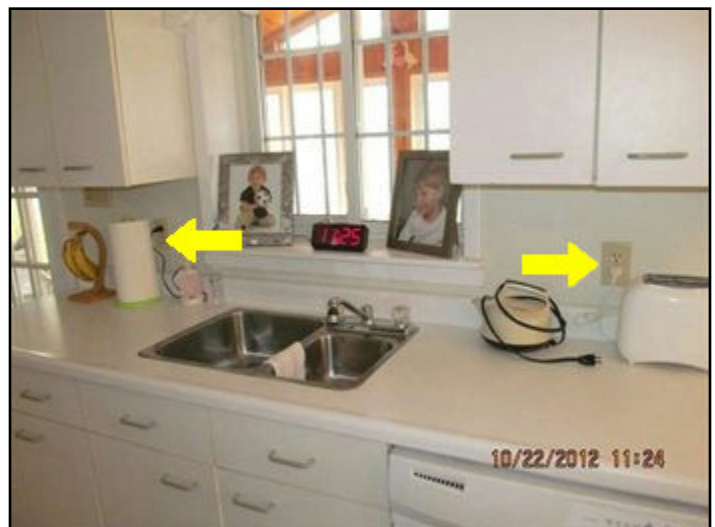
Recommend GFI protected outlets here

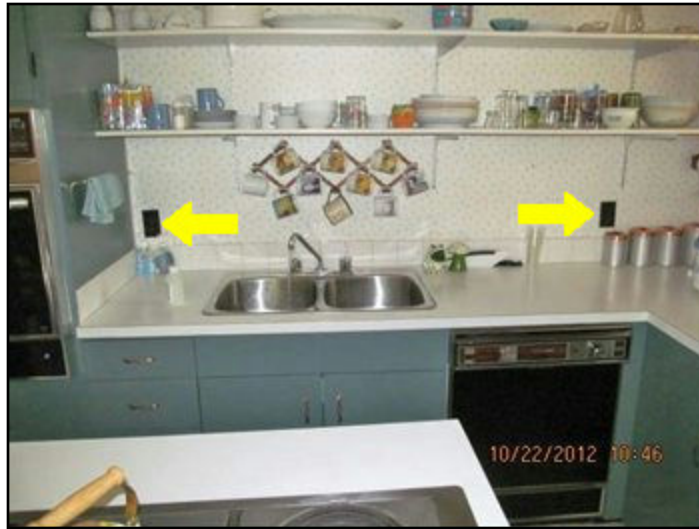
Recommend GFI protected outlets here

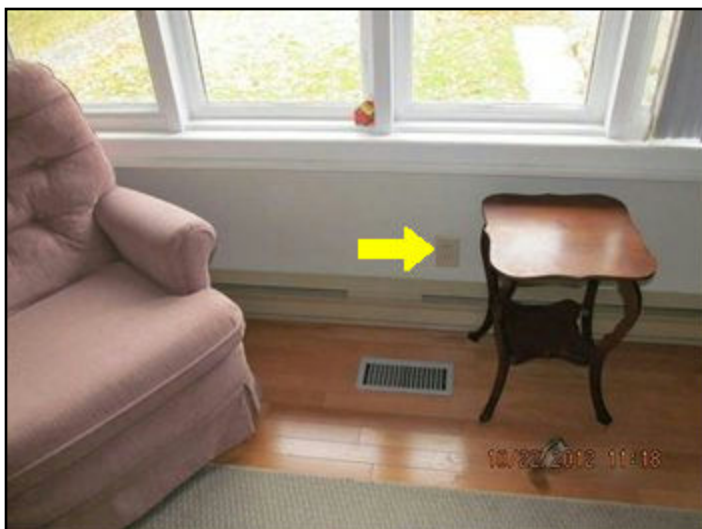
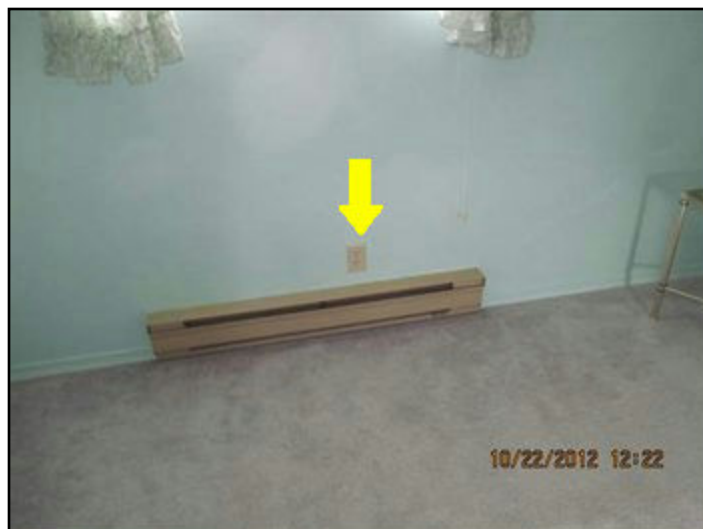
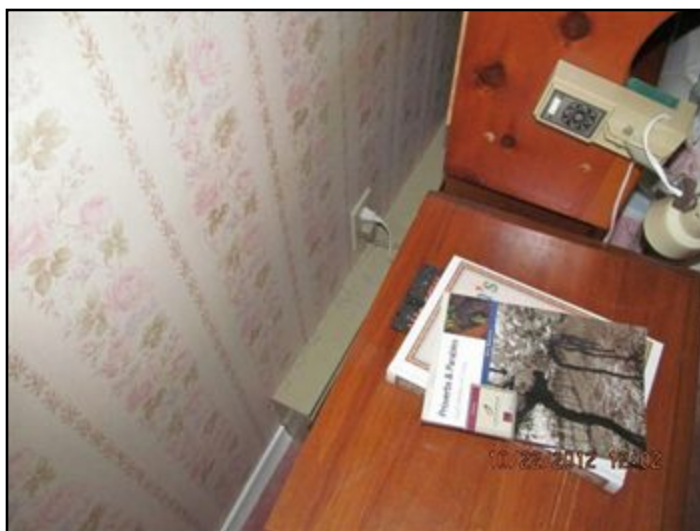
Condition: • [Above electric baseboard heaters](#)

Implication(s): Increased fire hazard

Outlet above baseboard heater

Task: Protect

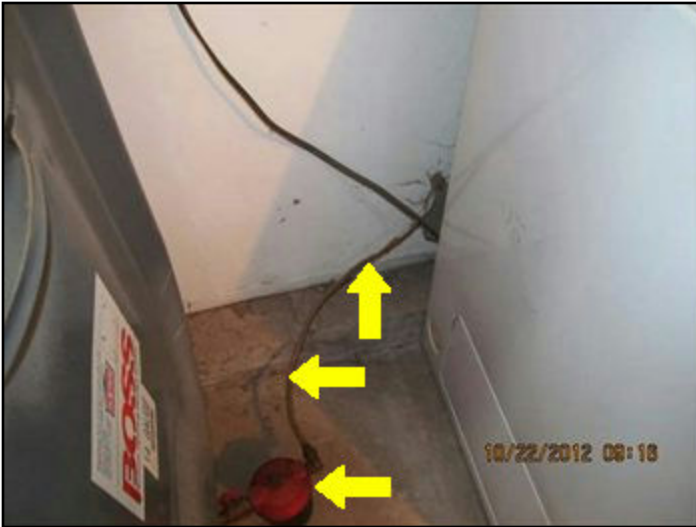
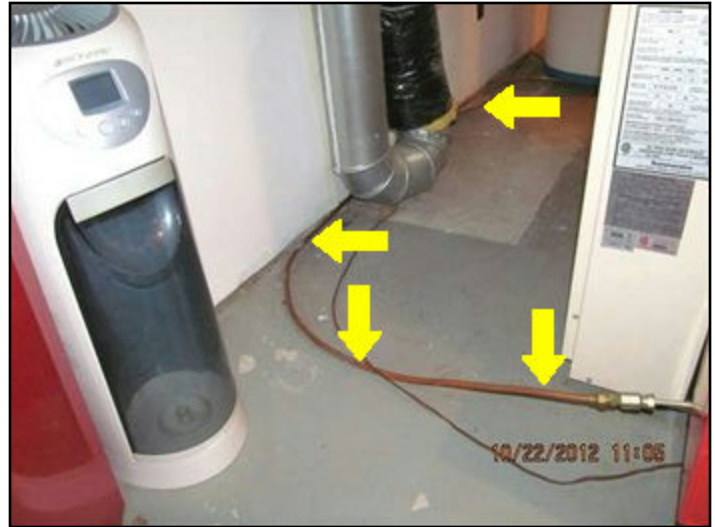
Condition: • [Unprotected](#)

Fuel line not vinyl coated

Task: Replace Upgrade

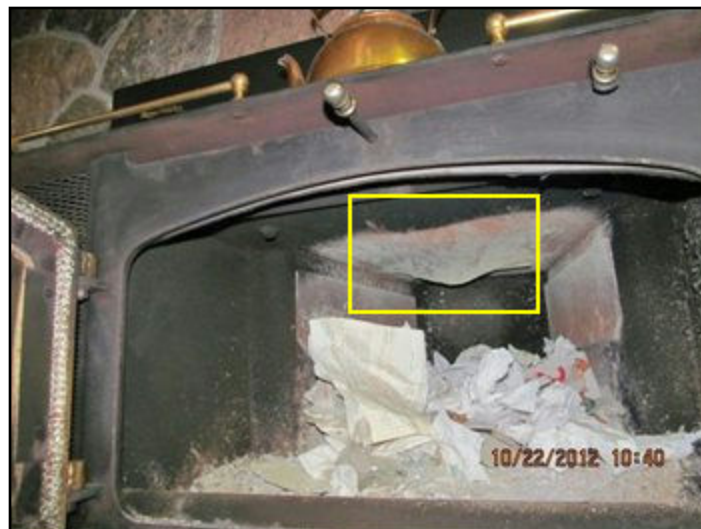
Condition: • [Warped or cracked](#)

The wood stove damper will not close because the inside of wood stove has warped. Air tight wood stove will work with damper open and adjust air flow with air flow control lever on right.

Implication(s): Increased fire hazard

Inside top panel warped

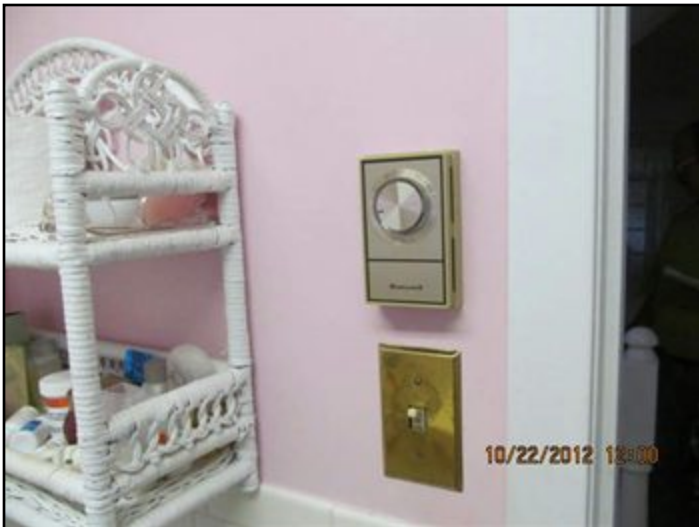
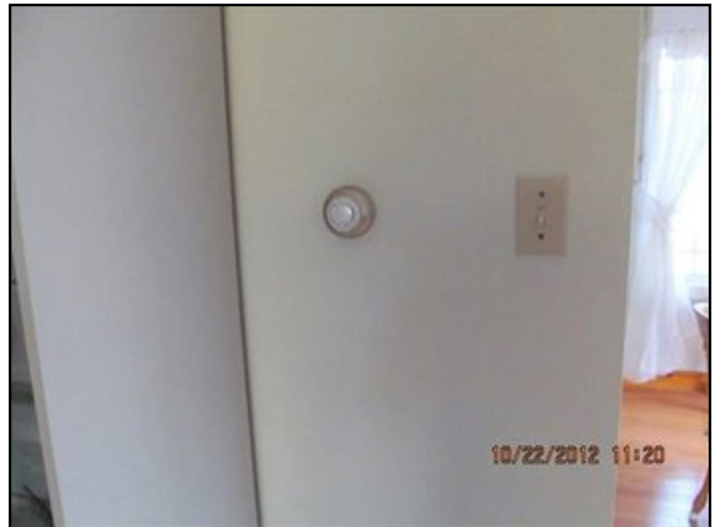
Condition: • When you don't need a lot of heat, the old thermostats go on, then off several minutes later, then on several minutes later again-- giving you full heat, then no heat, then full heat. Both extremes are uncomfortable, but that is unavoidable with the slow reaction time of old thermostats. Replace with electronic thermostats.

Old type of baseboard thermostat

Task: Upgrade

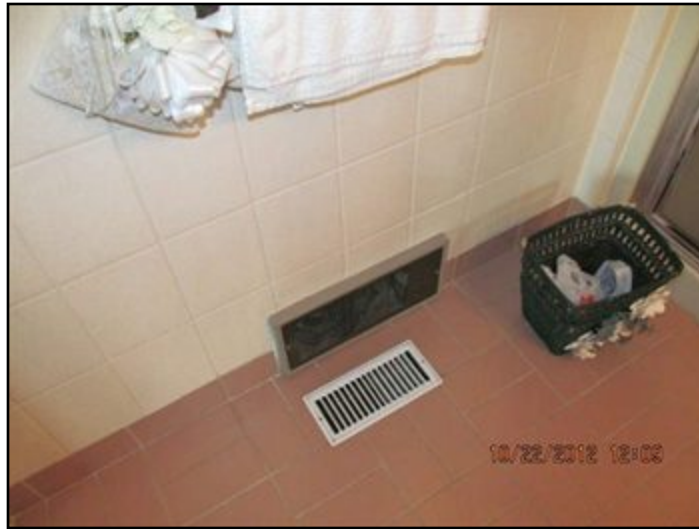
Condition: • Not working

Couple of wall heaters not working

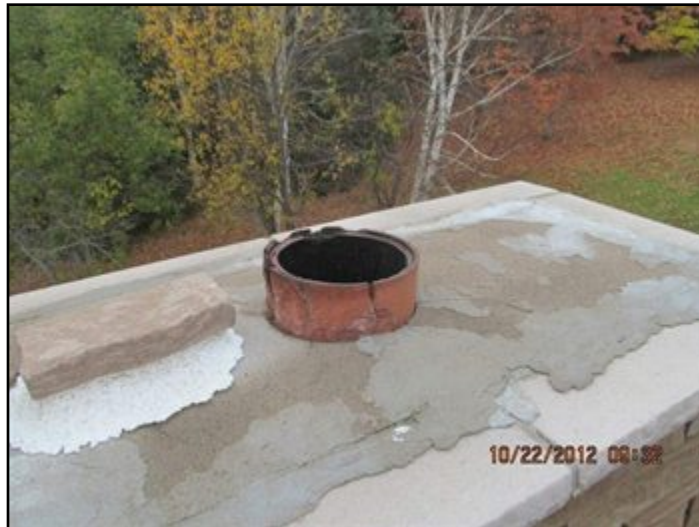
Condition: • Top clay flue tiles of chimney has deteriorated badly.

Top clay tile deteriorated

Task: Replace

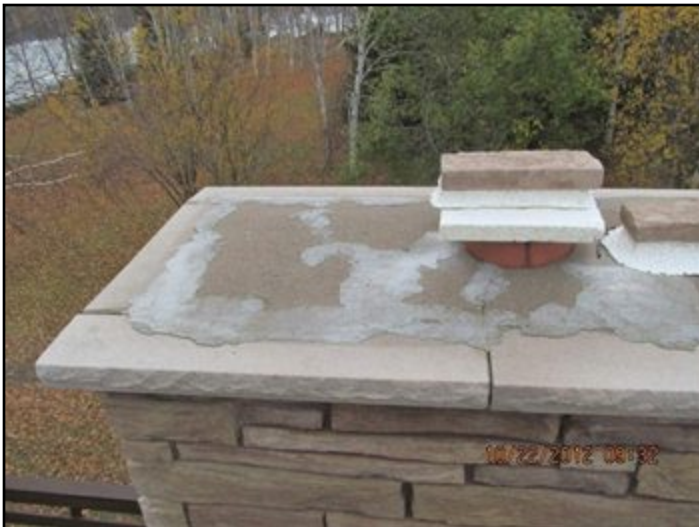
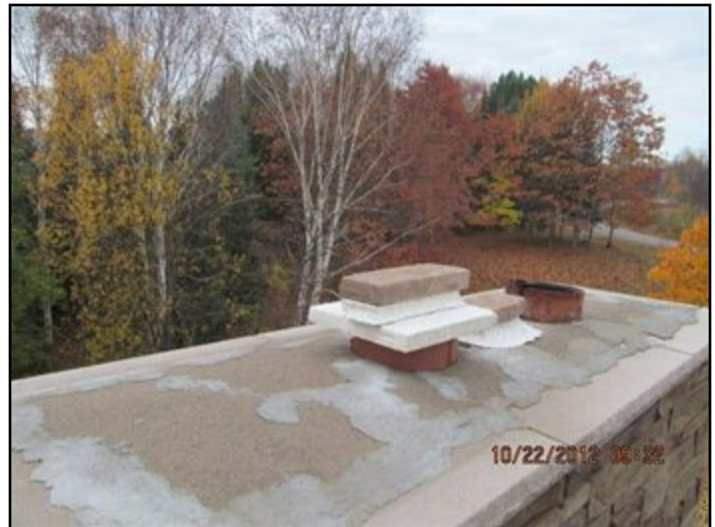
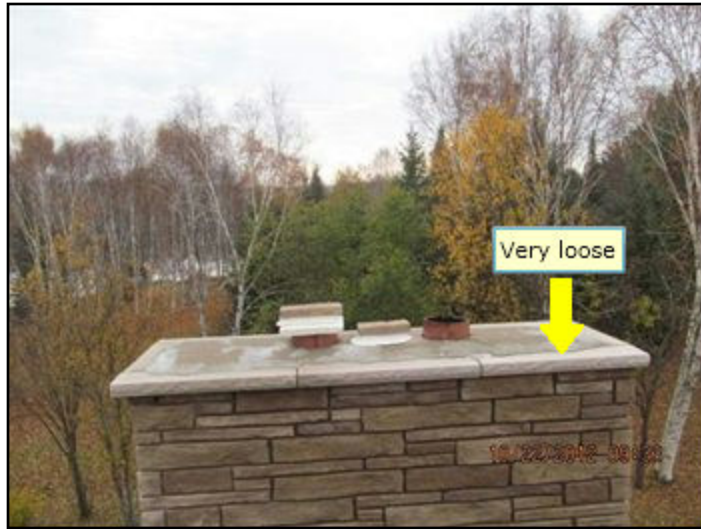
Condition: • [Cracked](#)

Chimney cap is badly cracked between masonry pieces, one of them can be lifted off. There is not a proper slope to allow water to run off.

Implication(s): Chance of water damage to contents, finishes and/or structure | Shortened life expectancy of material

Chimney cap cracked

Task: Replace

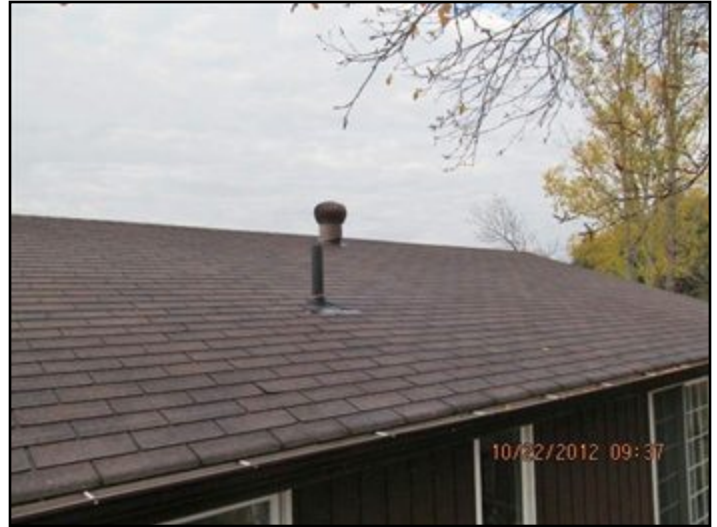
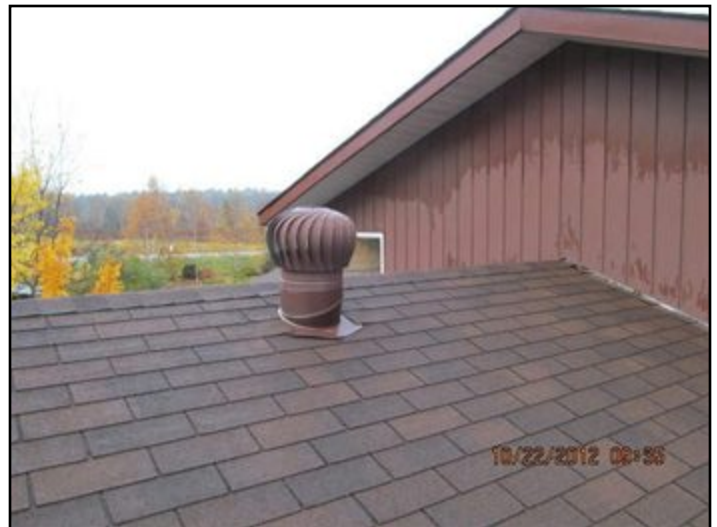
Condition: • [Inadequate](#)

Wind turbine not enough ventilation

Vent recommended is: "Maximum" web site is: <http://www.ventilation-maximum.com/> Replace both the turbine vents.

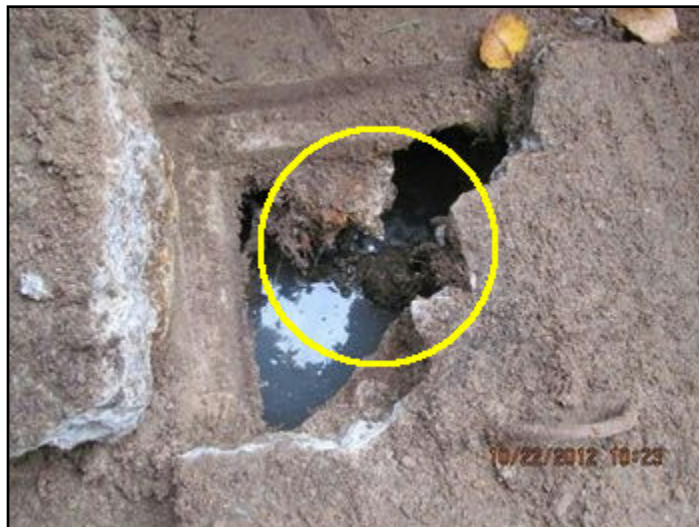
• Outlet baffle has deteriorated to the point that it has to be replaced. To replace baffle the tank will have to be pumped out.

Outlet baffle just about gone

Pump out septic tank next spring and have outlet baffle replaced.

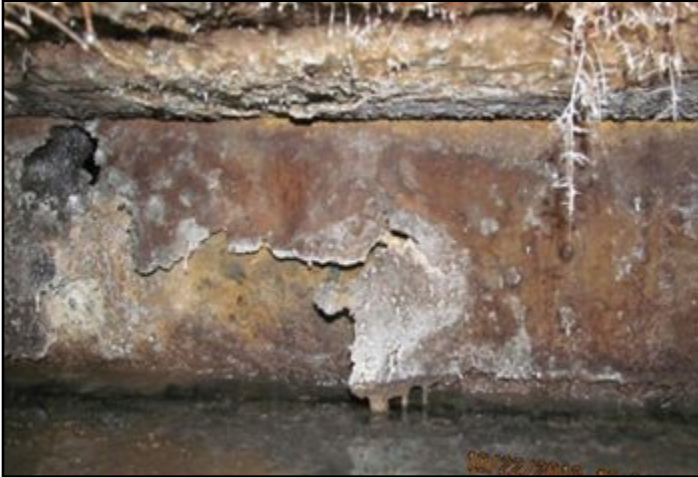
Outlet chamber showing deterioration

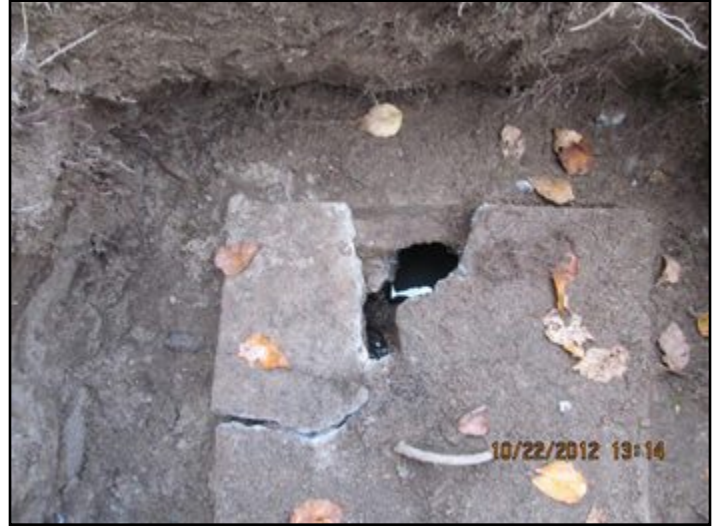
- Visually inspect septic tank every couple of years for baffle condition and whether tanks needs pumped out.
- Outlet chamber lid deteriorating.
Did not lift outlet chamber lid as it was wedged in and would of broken into more pieces. Need to replace outlet chamber lid with a new one.

Outlet chamber lid badly cracked

Outlet chamber lid needs to be replaced.

Task: Replace

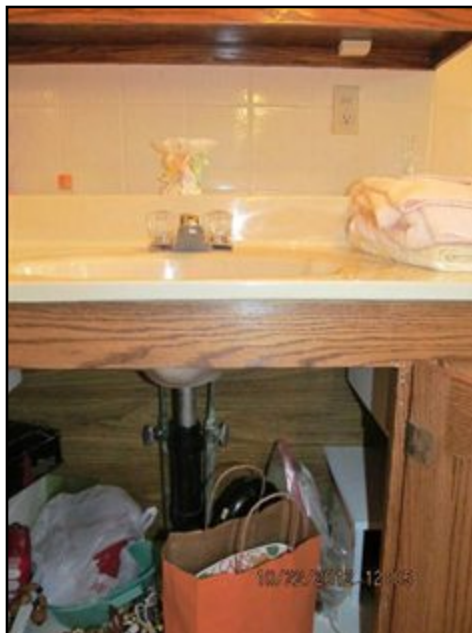
Condition: • [Stiff or inoperative](#)

Cold water shut off

Task: Repair

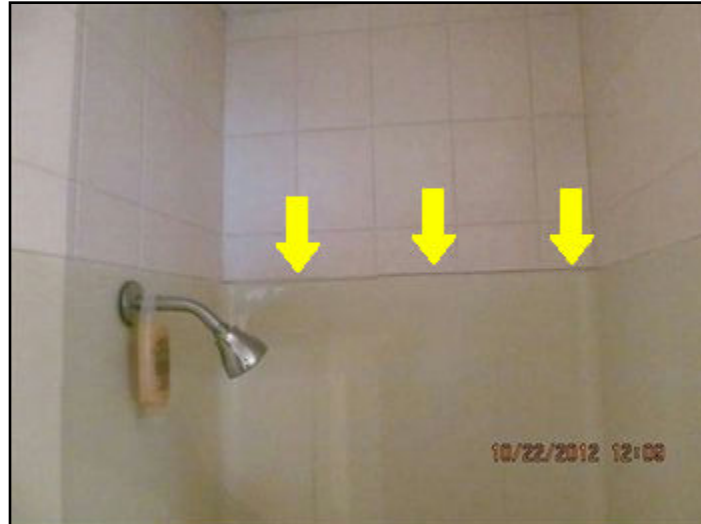
Condition: • [Caulking loose, missing or deteriorated](#)

Cracking above shower panel

Task: Repair

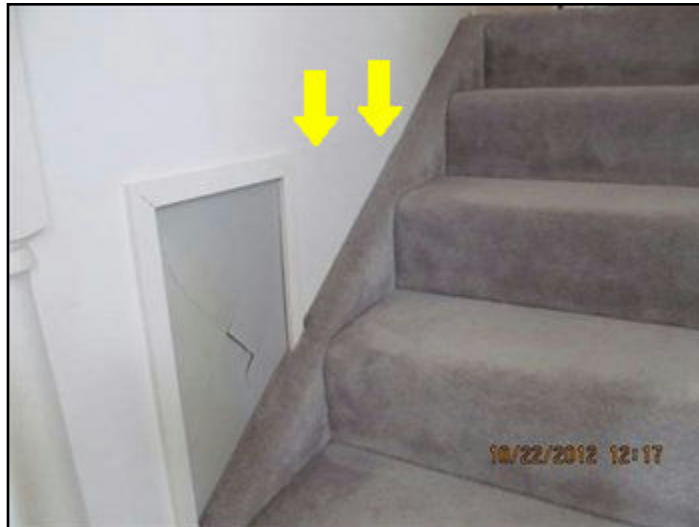
Condition: • [Cracked](#)

Small crack in wall

Task: Repair

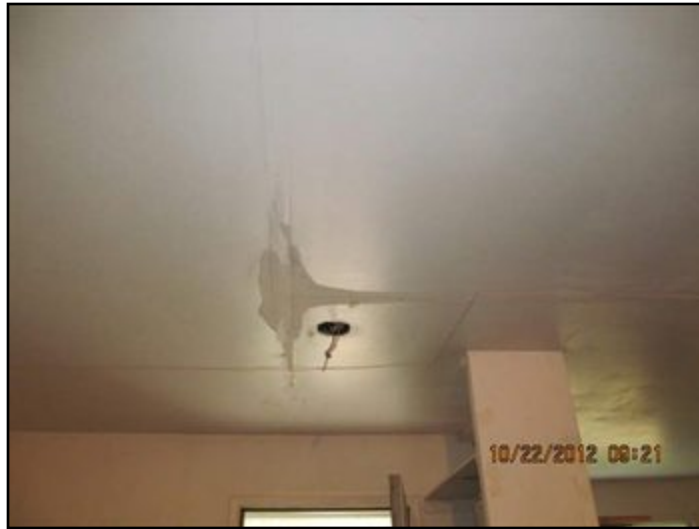
Condition: • [Water damage](#)

Previous water damage

Task: Repair

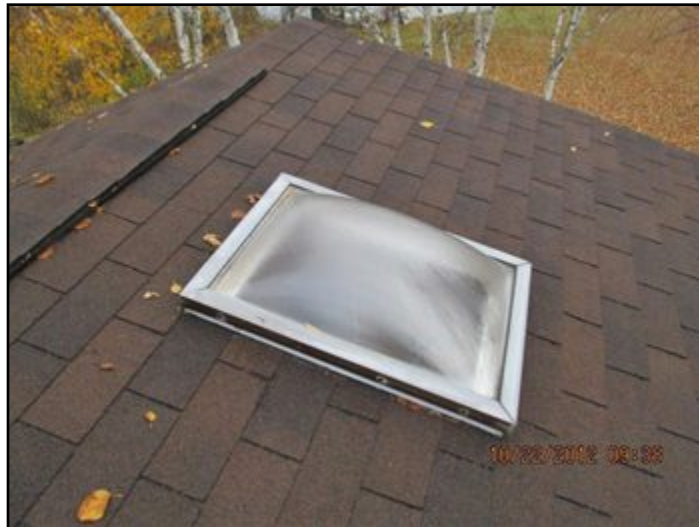
Condition: • There was a lot of accumulation of condensation in skylight.

A lot of condensation on skylight

Task: Monitor

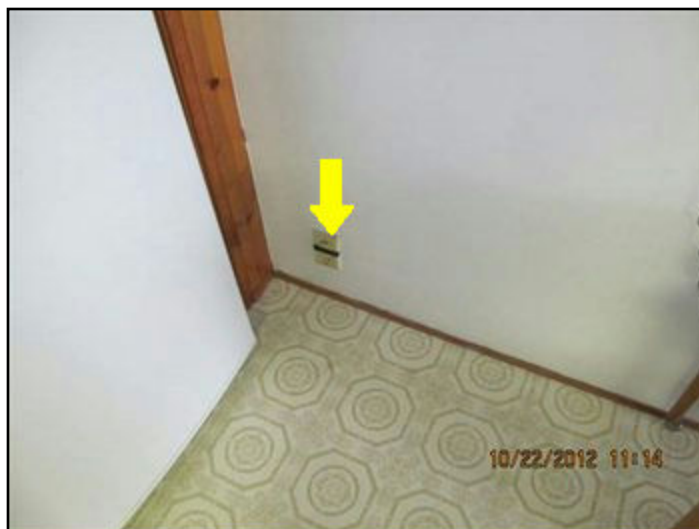
Condition: • Hose receptacles - loose/damaged/leaky

Central vac outlet closed off

Task: Repair or replace
