YOUR Inspection Report

321 Your Street
Newmarket, ON K0M 2C0

INSPECTION DATE:
Friday, September 14, 2012

RE: Report No. 2144, v.2
321 Your Street
Newmarket, ON
K0M 2C0

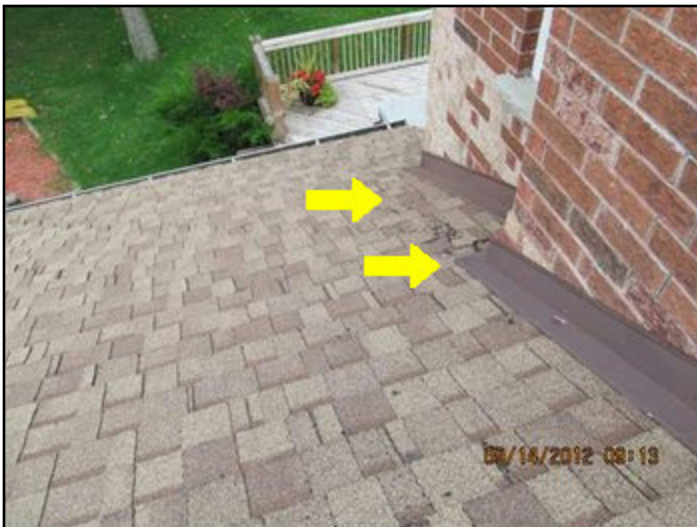
Condition: • [Cupping, curling, clawing](#)

Shingles showing deterioration because of lack of ventilation in garage. The roof vents have not been cut fully open.

Shingles showing wear

Task: Monitor

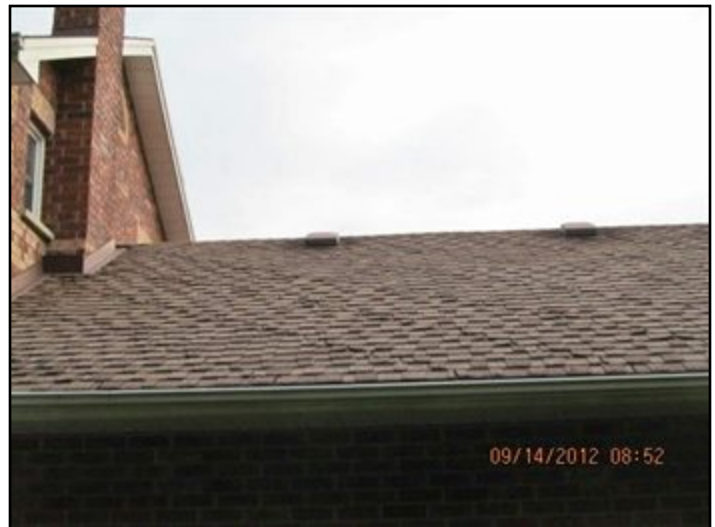
Shingles starting to curl

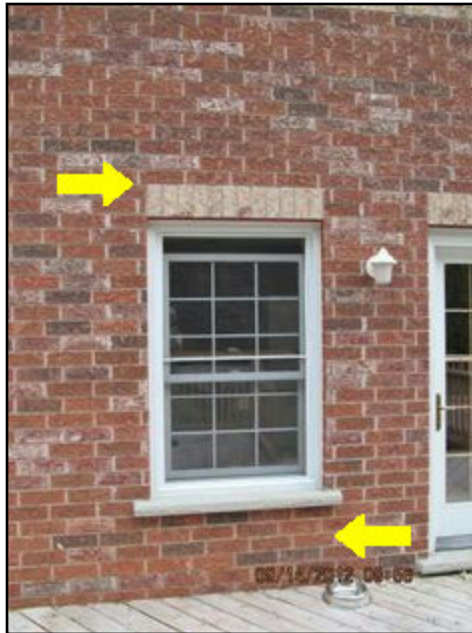
Condition: • [Cracked](#)

Cracks in brick facing

Repoint any cracks between bricks. Top left and bottom right.

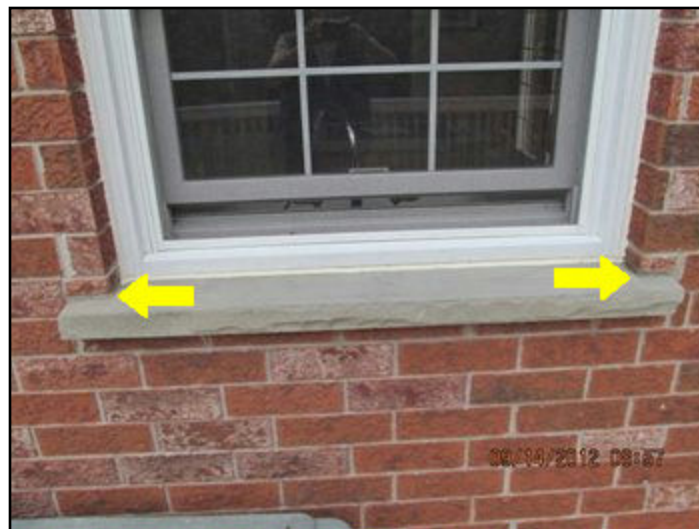
Condition: • [Caulking loose, missing or deteriorated](#)

Caulk around window ledges

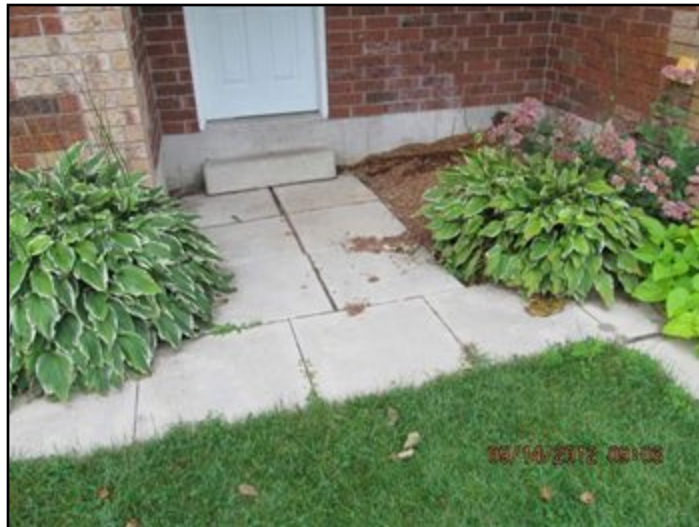
Condition: • [Improper slope](#)

Walkway sloped towards foundation

Lift stones and reslope walkway away from foundation.

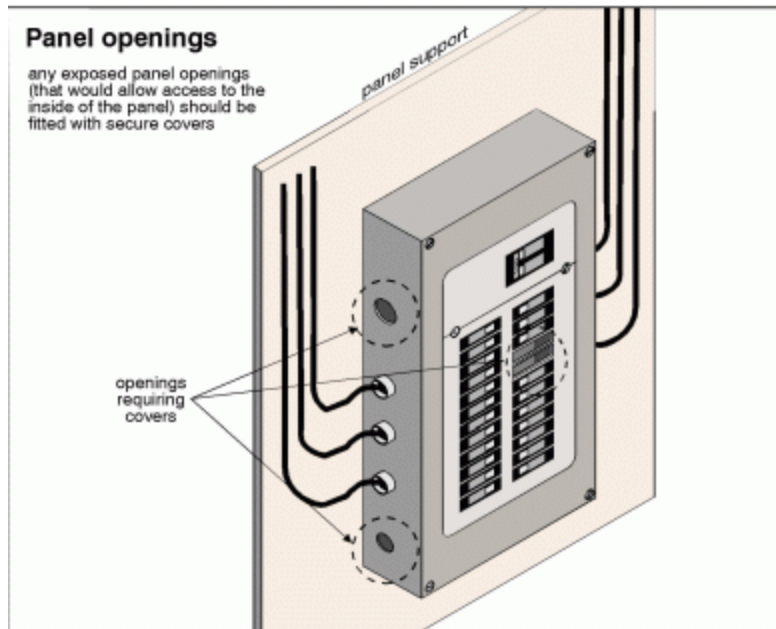
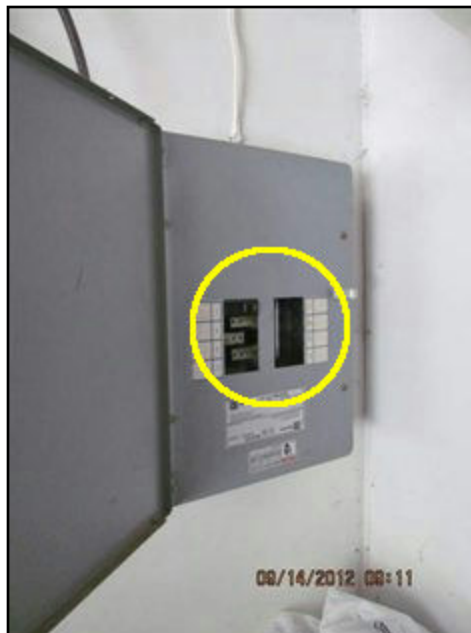
Condition: • [Openings in panel](#)

Openings in electrical panel

Task: Protect

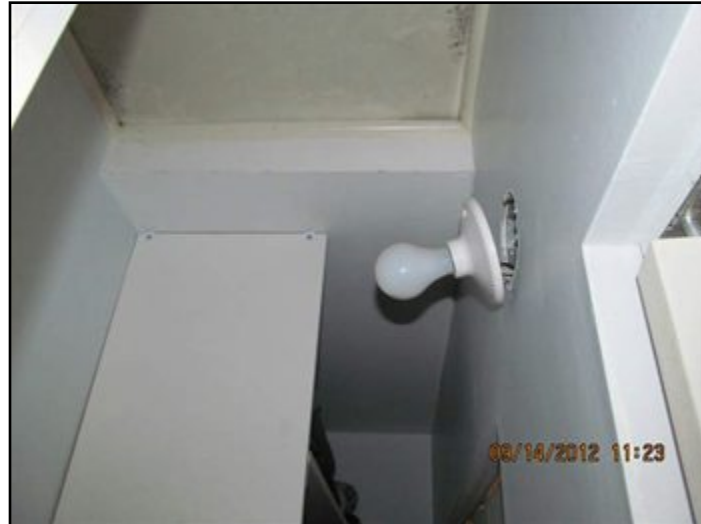
Condition: • [Loose](#)

Light loose in closet

Task: Repair

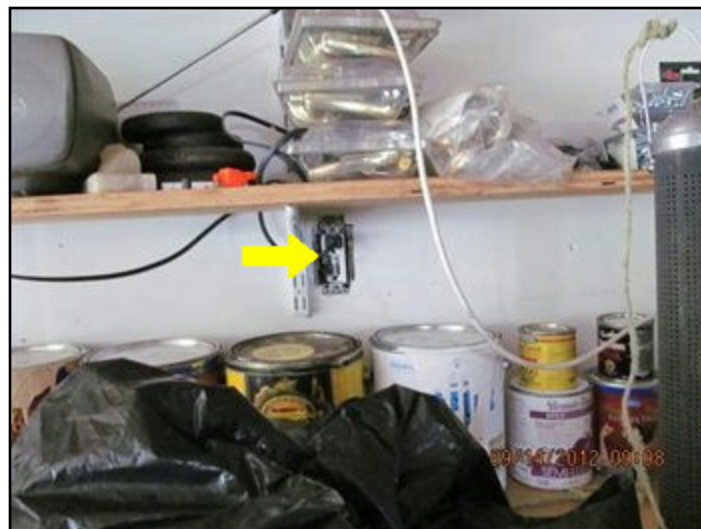
Condition: • [Damage](#)

Damaged outlet

Task: Replace

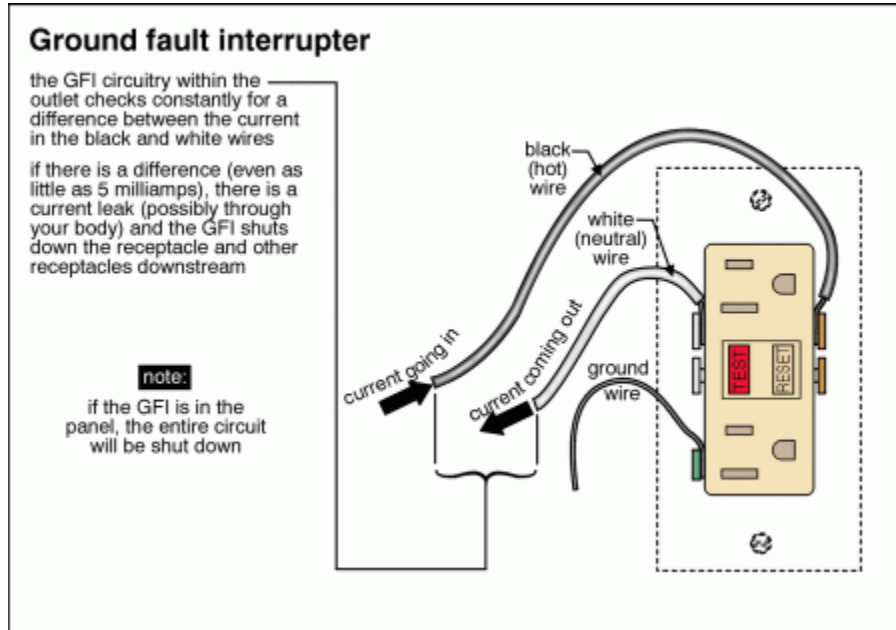
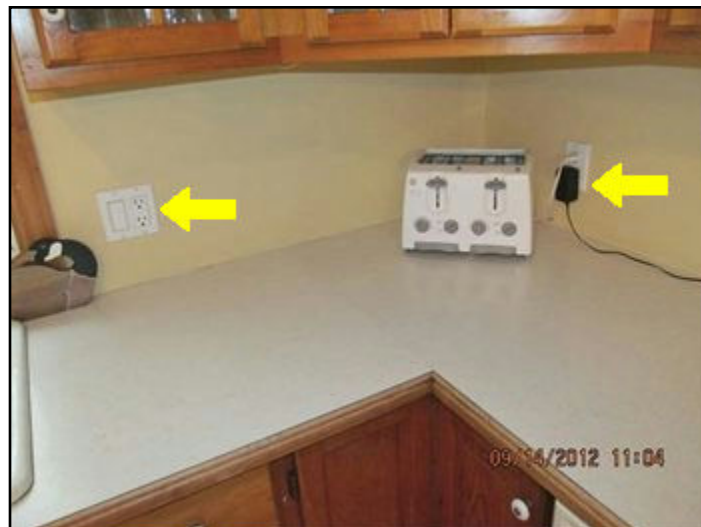
Condition: • [No GFI \(Ground Fault Interrupter\)](#)

Recommend GFI protected outlets here

Task: Replace

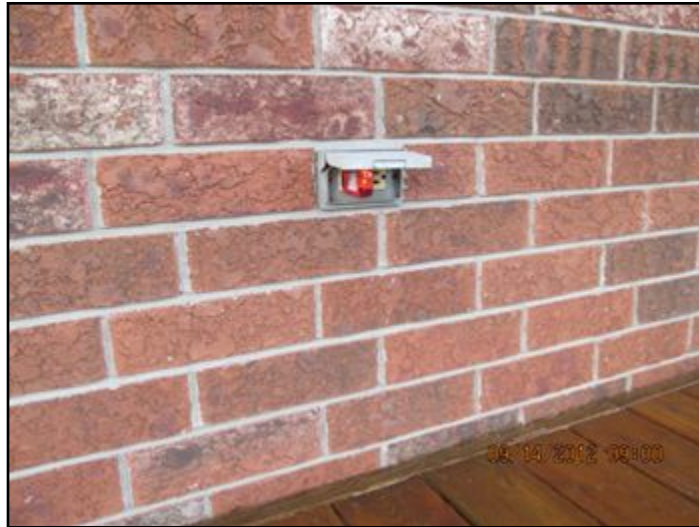
Condition: • [GFI test faulty](#)

GFI faulty

Task: Replace

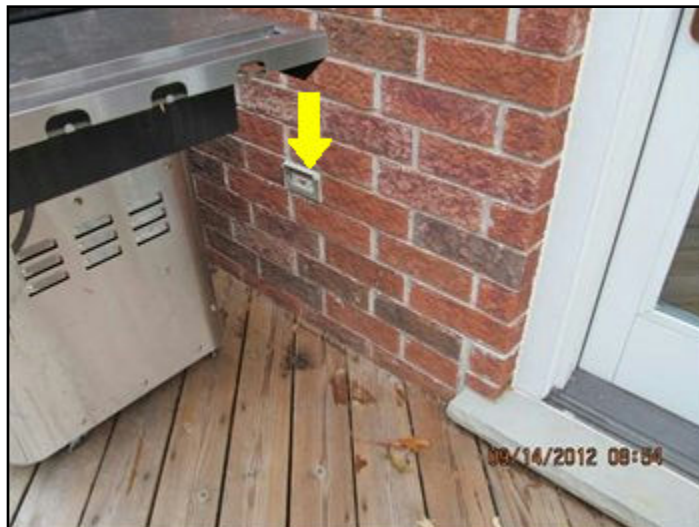
Condition: • [Missing](#)

Weatherproof cover plate missing

Task: Provide

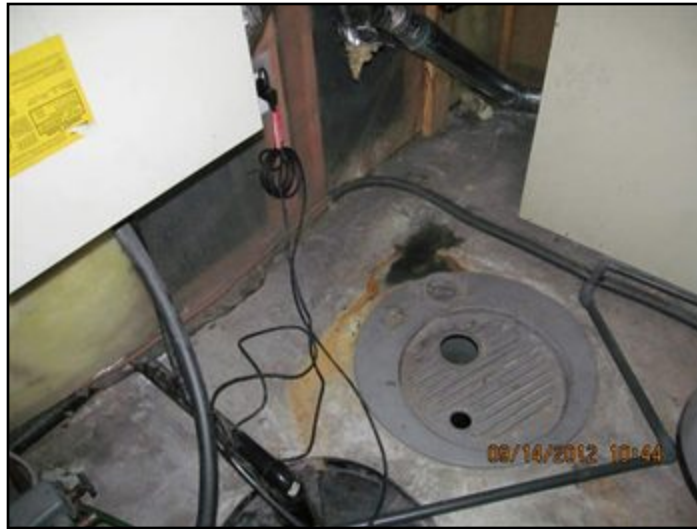
Old oil fuel lines

Is the interior fuel line protected from damage (vinyl coated) ?: • No

• Oil line from oil tank to furnace and oil fired hot water tank need to be replaced.

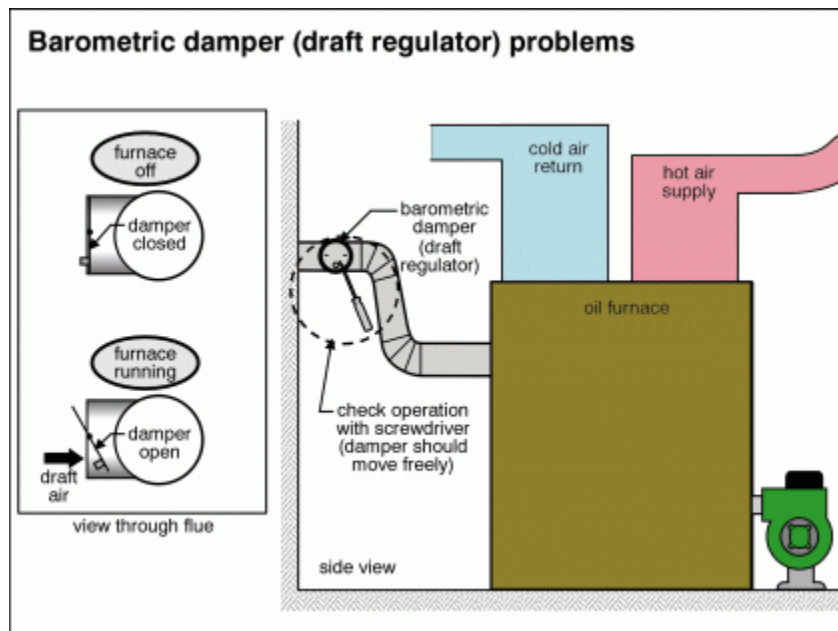
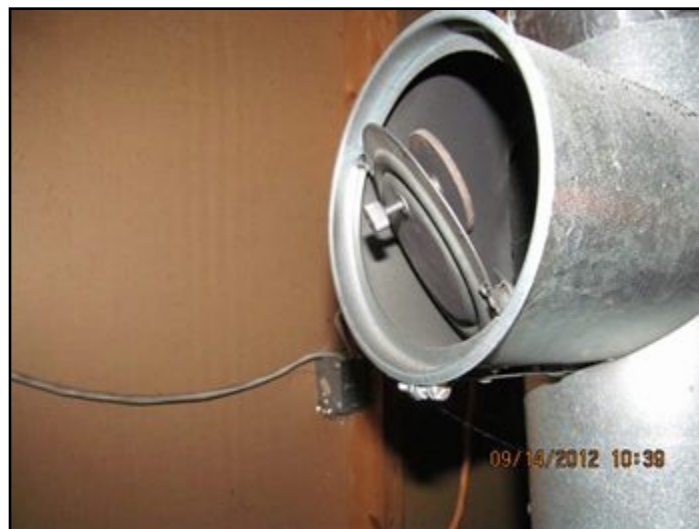
Condition: • [Misadjusted](#)

Implication(s): Equipment not operating properly | Hazardous combustion products entering home | Increased operating costs

Barometric damper not working

Task: Service

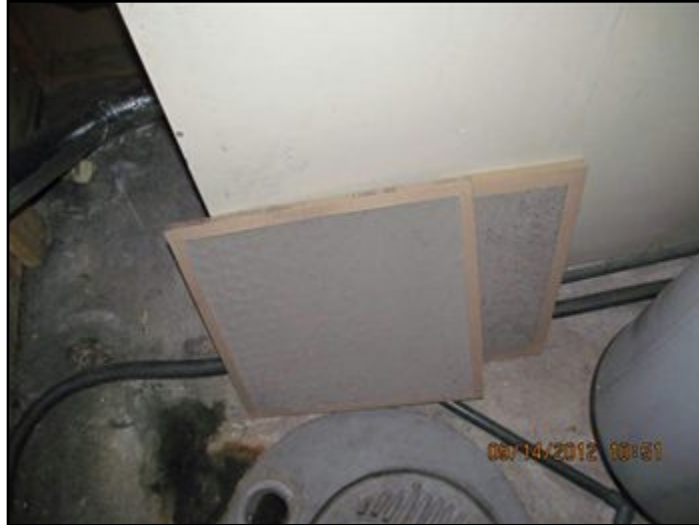
Condition: • [Dirty](#)

Furnace air filters removed

Task: Replace

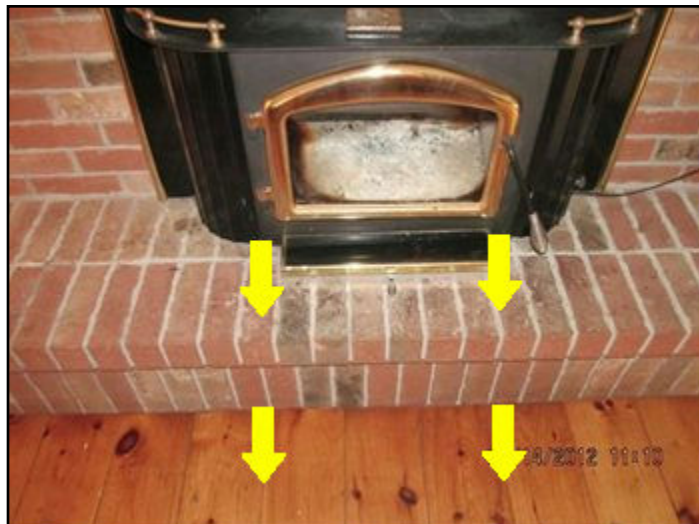
Condition: • [Floor - combustible clearance inadequate](#)

Implication(s): Increased fire hazard

Hearth too small

Task: Correct

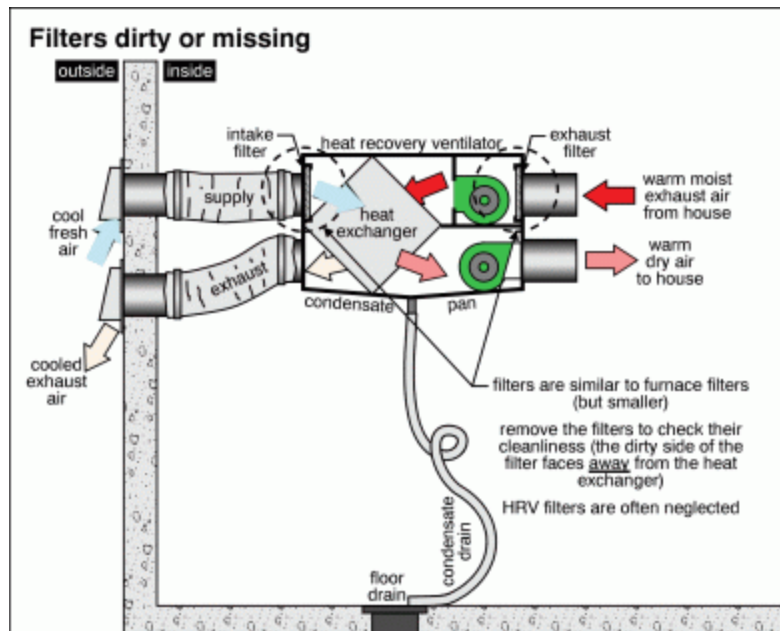
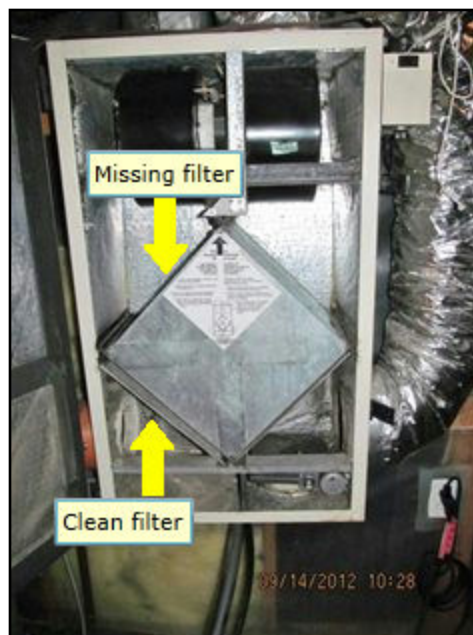
Condition: • [Missing](#)

HRV unit needs cleaned

HRV unit is missing a washable screen. Need to wash existing mesh screen and pull complete core out and clean that as well.

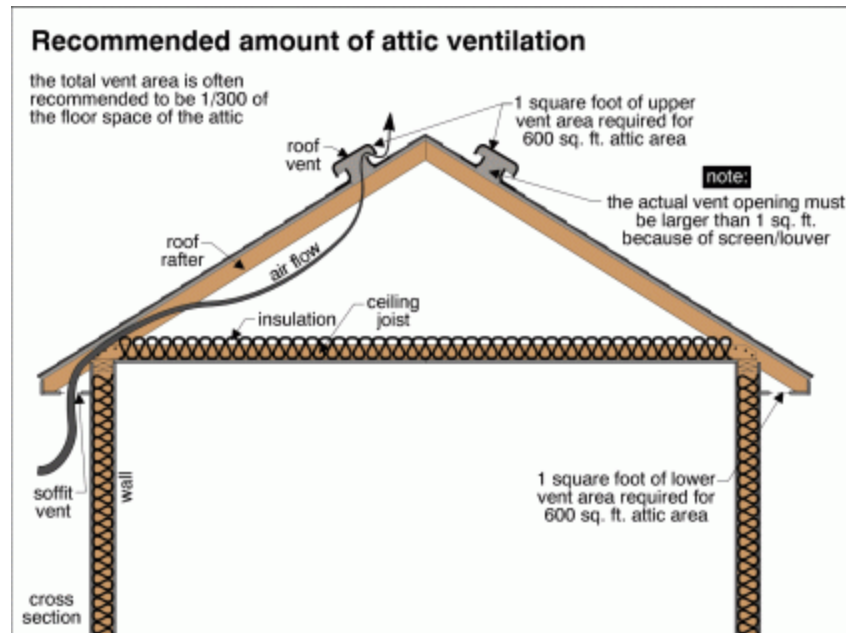
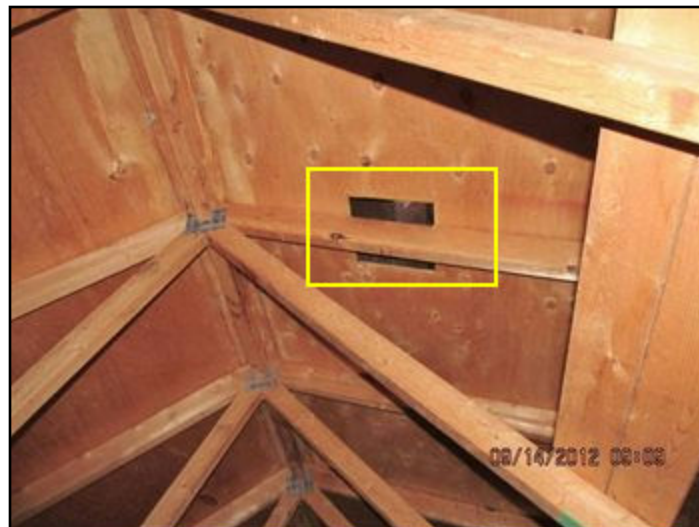
Condition: • [Obstructed](#)

Roof vent not completely open

Task: Correct

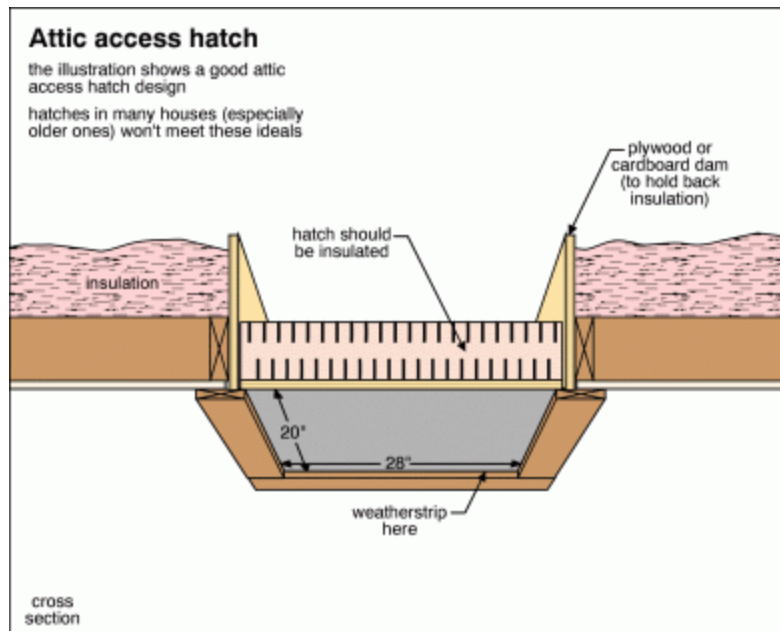
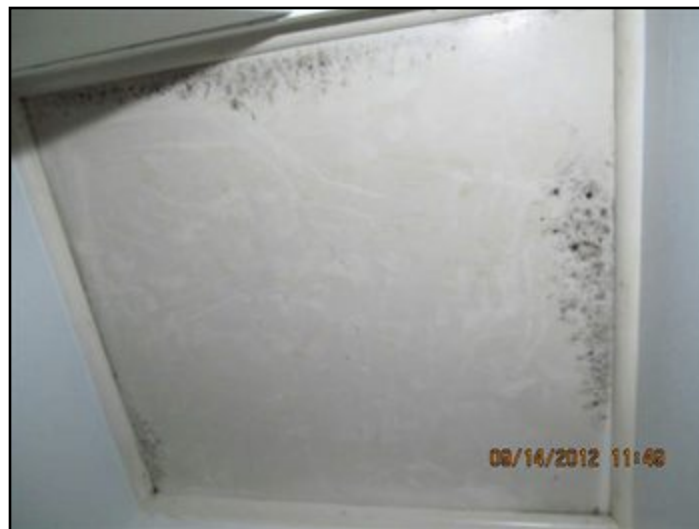
Condition: • [Not weatherstripped](#)

Air leakage around attic hatch

Ideally, best to caulk around edges of attic hatch to prevent air leakage into attic.

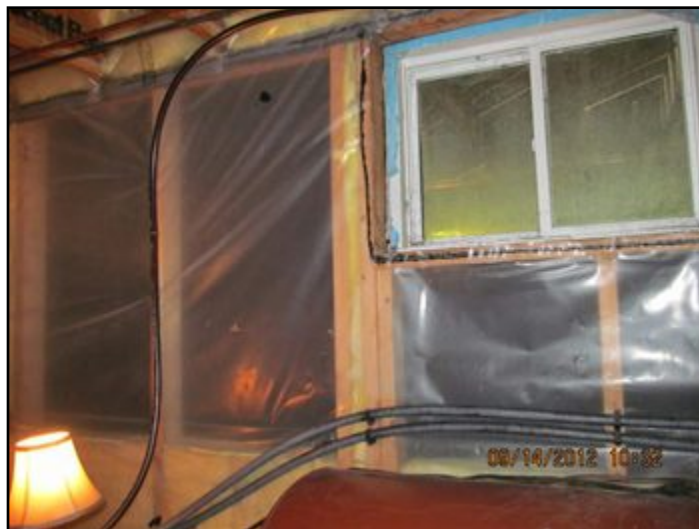
Condition: • [Loose, sagging or voids](#)

Missing insulation

Task: Replace

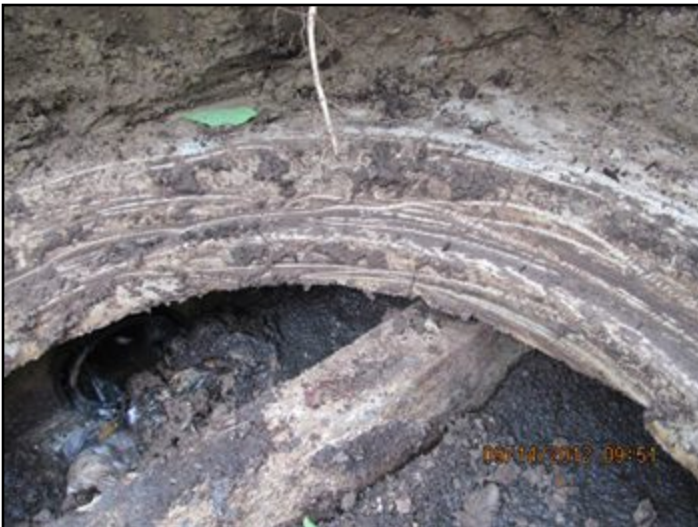
• Septic tank is deteriorating faster than normal because of water softener back washing into septic tank. It also has a few cracks in top.

Cracks in septic tank

Condition of tank: • Cracks in tank

Task: Monitor, discharge softener into sump pump

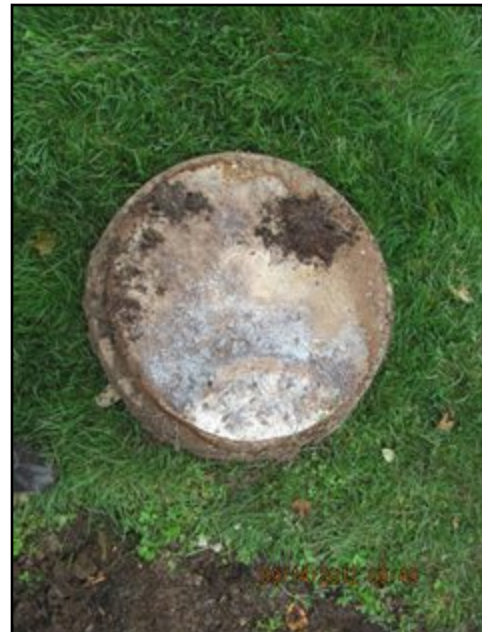
Outlet chamber lid showing deterioration

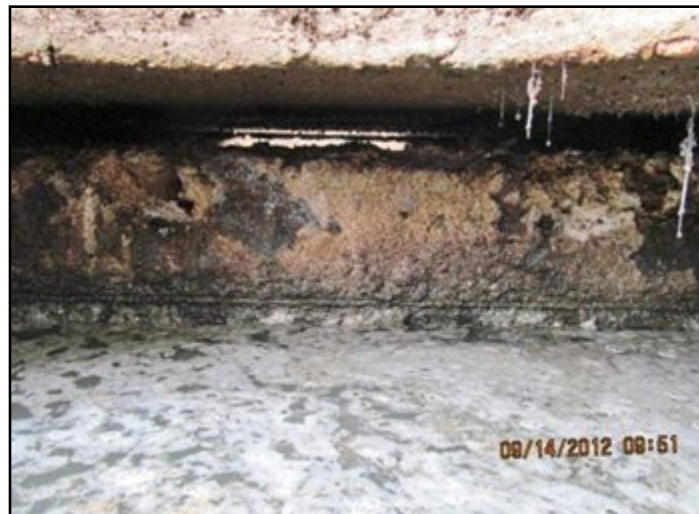
Interior baffle showing deterioration

Condition of tank: • Interior baffle deteriorating

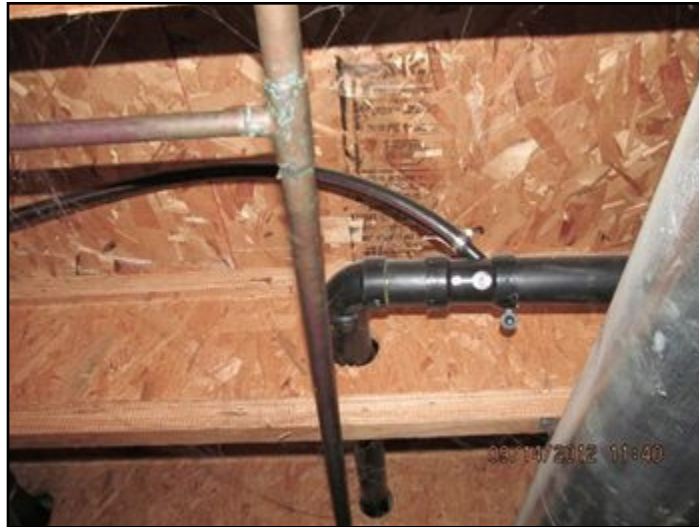
Existing water softener discharge location

Task: Correct

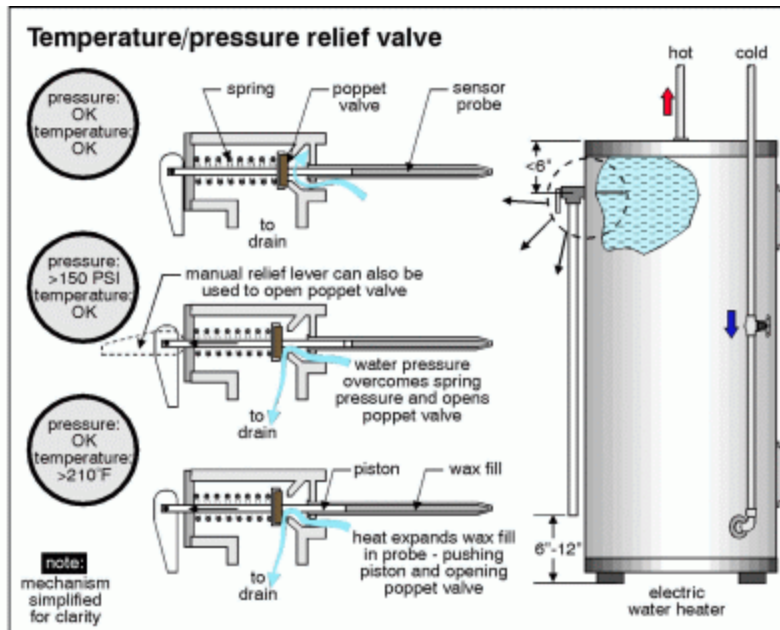
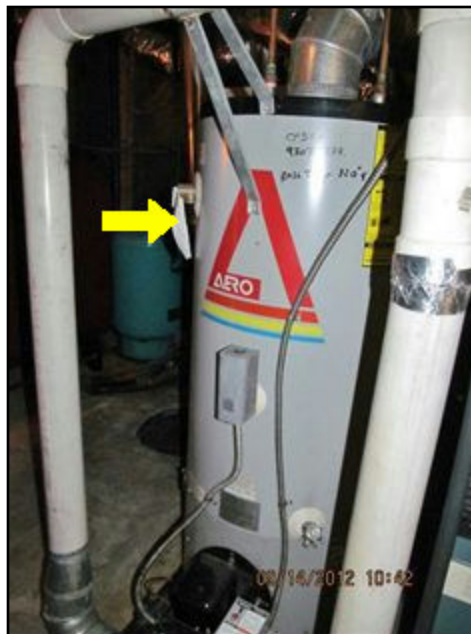
Condition: • [Discharge tube missing](#)

Discharge tube missing

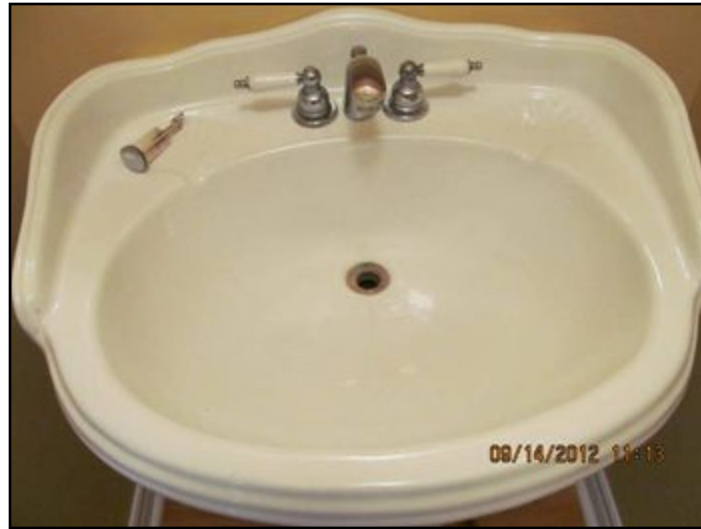
Condition: • [Surface defects](#)

Cracked sink

Task: Replace

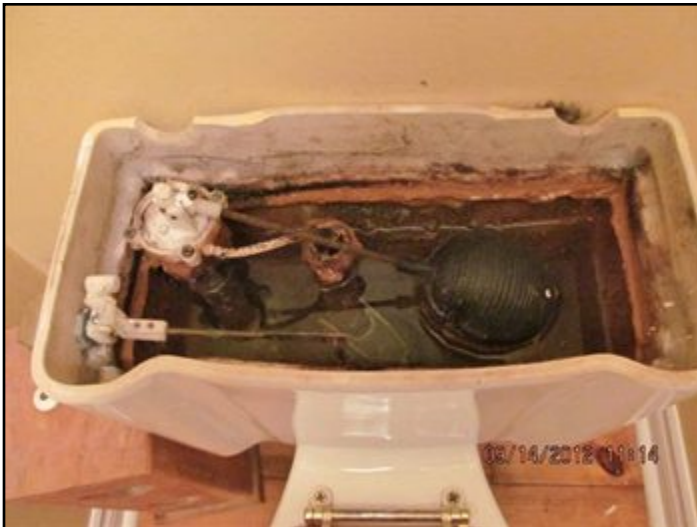
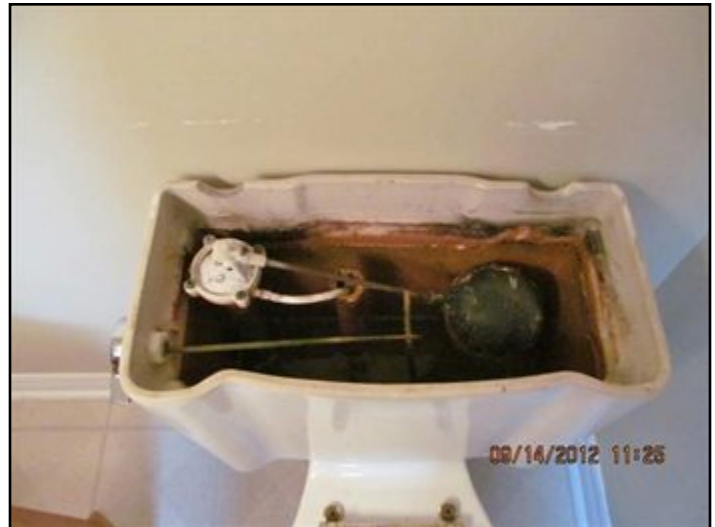
Condition: • [Obstructed or weak flush](#)

Toilet not flushing properly

Task: Repair

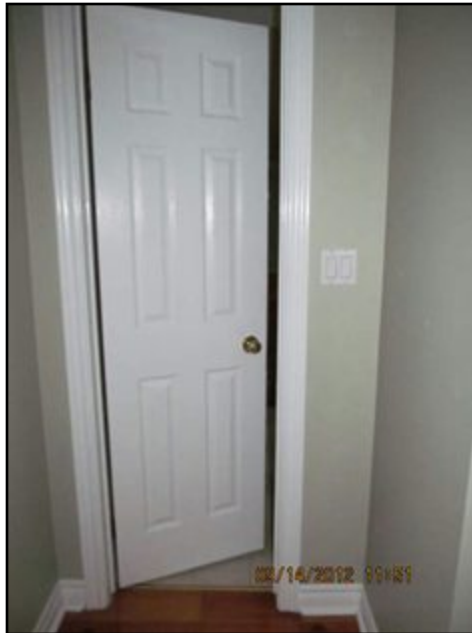
Condition: • [Stiff](#)

Door would not close

Task: Repair

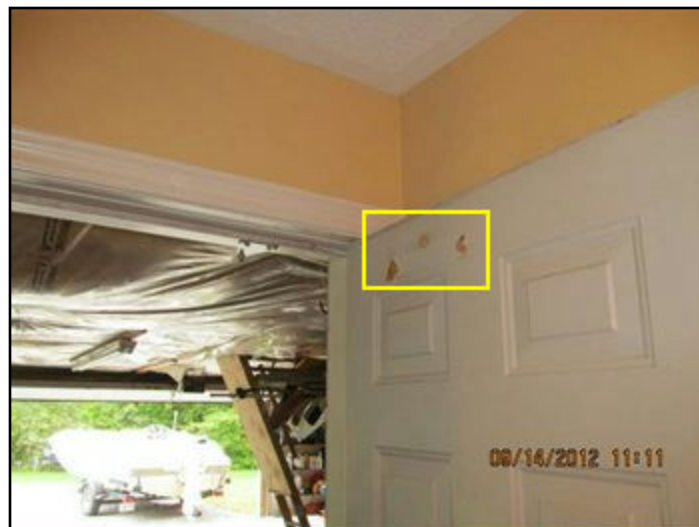
Condition: • [Self-closer missing](#)

Implication(s): Hazardous combustion products entering home

Self closer missing

Task: Replace

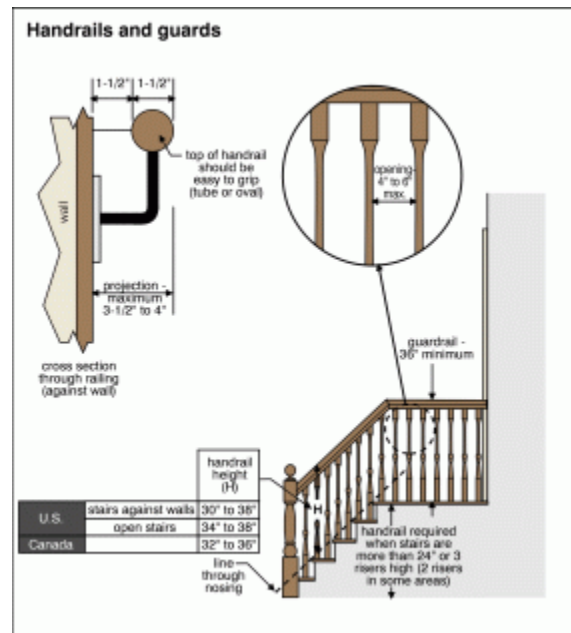
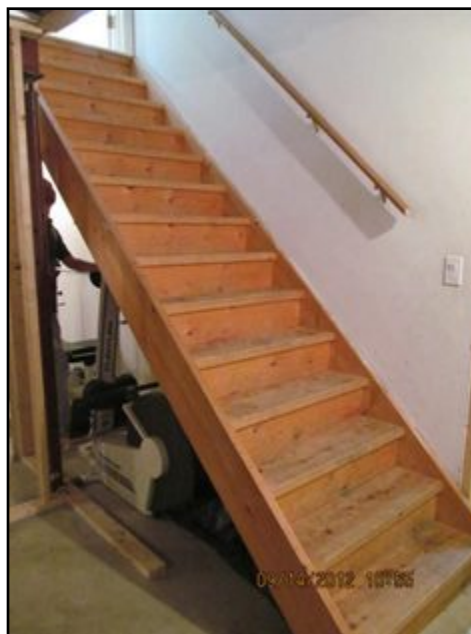
Condition: • [Missing](#)

Implication(s): Fall hazard

Guard rail missing

Task: Provide

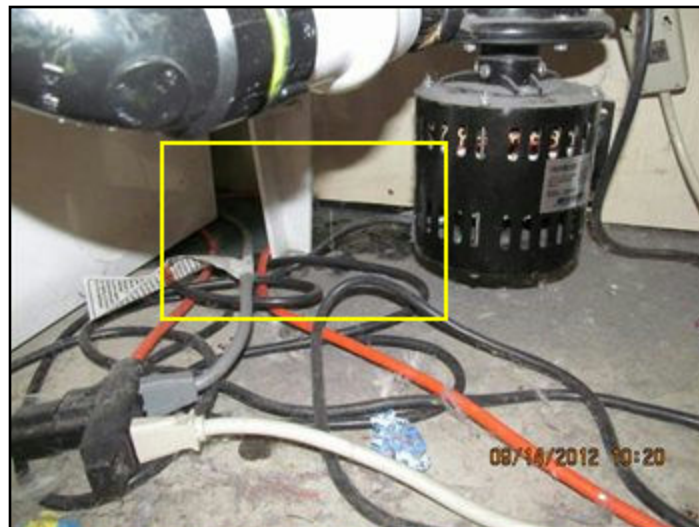
Condition: • [Water on floor](#)

Water on floor

Task: Further evaluation

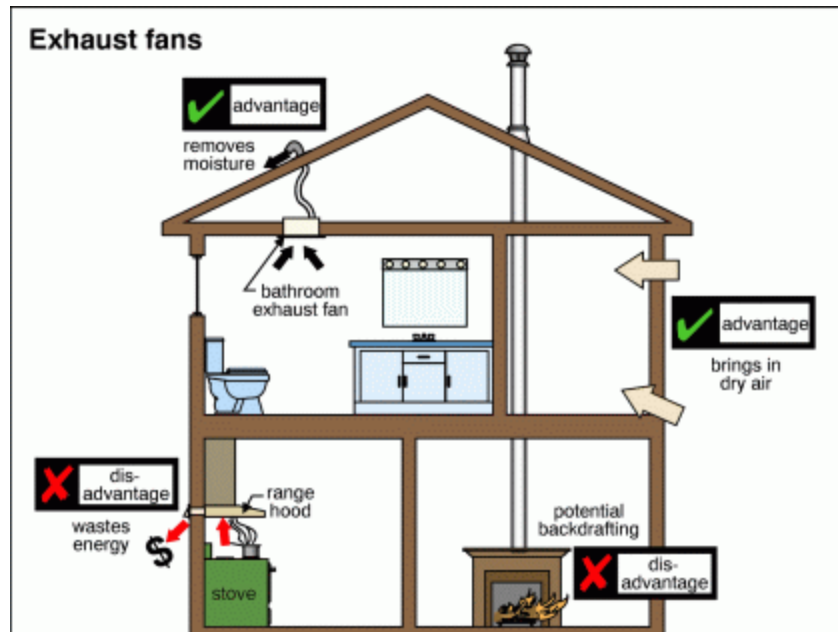
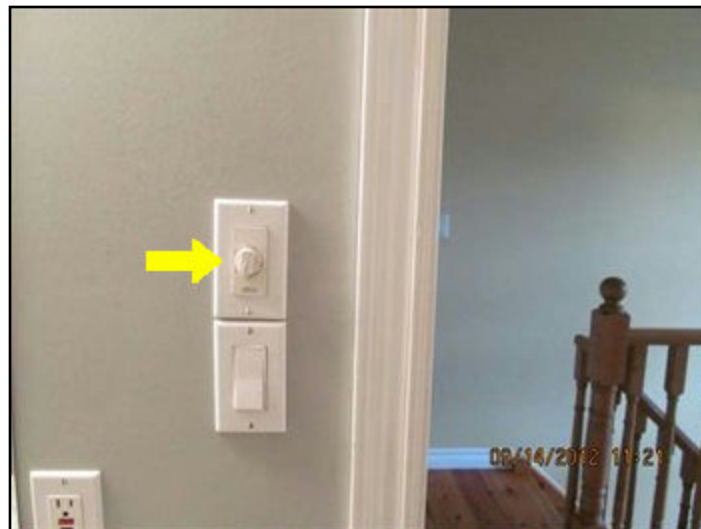
Condition: • [Missing](#)

Fan switch
