YOUR Inspection Report

321 Your Street
Newmarket, ON K0M 2C0

INSPECTION DATE:
Friday, September 14, 2012

RE: Report No. 2144, v.2
321 Your Street
Newmarket, ON
K0M 2C0

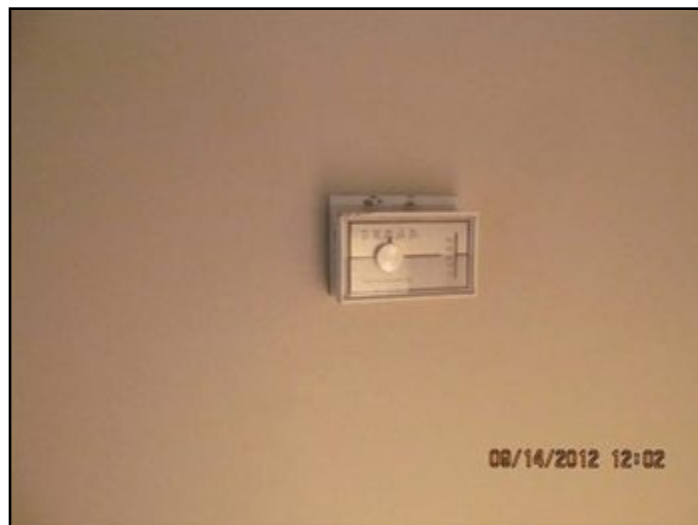
Task: Upgrade

Existing thermostat

1. Upgrade thermostat
2. HRV unit needs a filter and a total clean
3. Install missing insulation in furnace room
4. Install a discharge tube on hot water tank
5. Replace bathroom sink and adjust flushing flaps
