YOUR Inspection Report

123 Lake Front Road
Cottage Country, ON P1L 1L4

Monday, October 22, 2012

RE: Report No. 2179, v.2
123 Lake Front Road
Cottage Country, ON
P1L 1L4

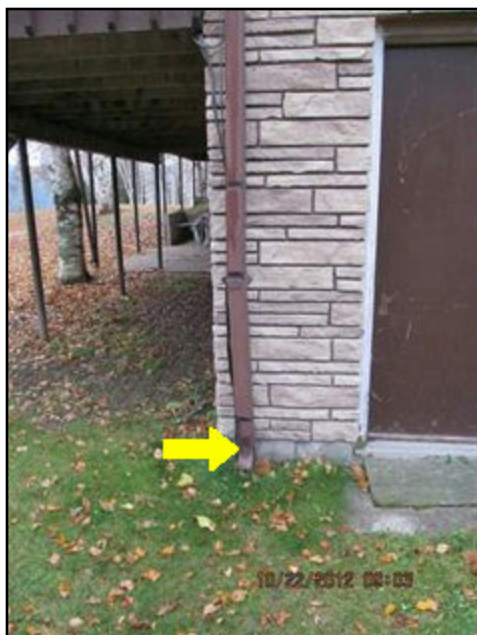
Extend downspout

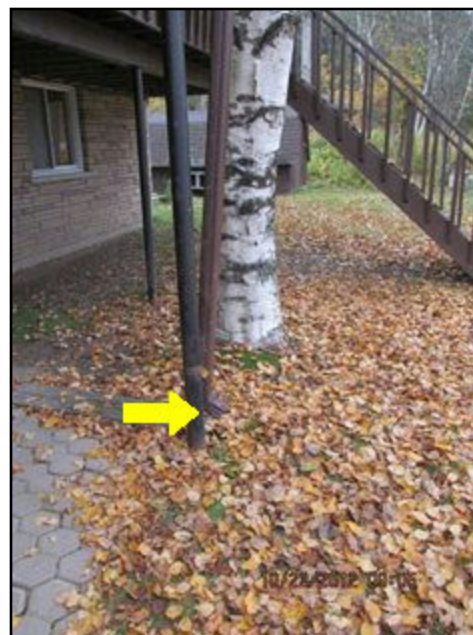
Extend downspout

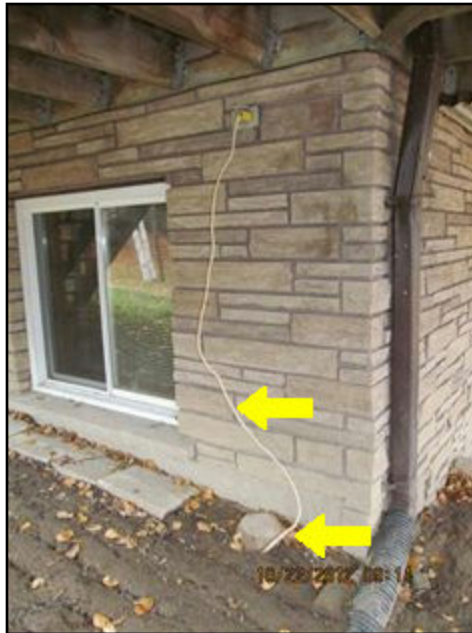
Electrical wire buried

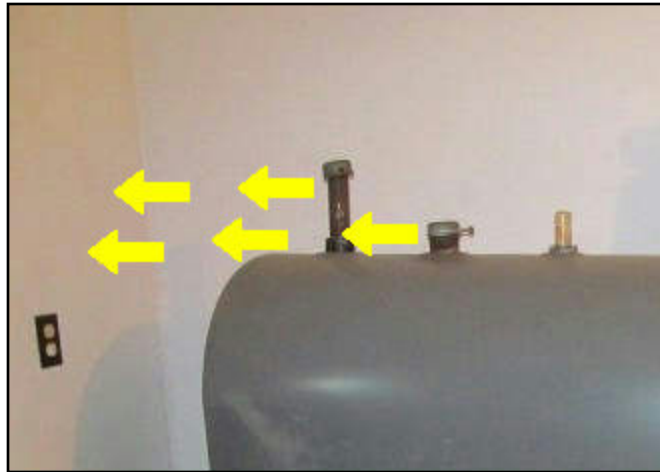
Oil fill/vent pipes in garage

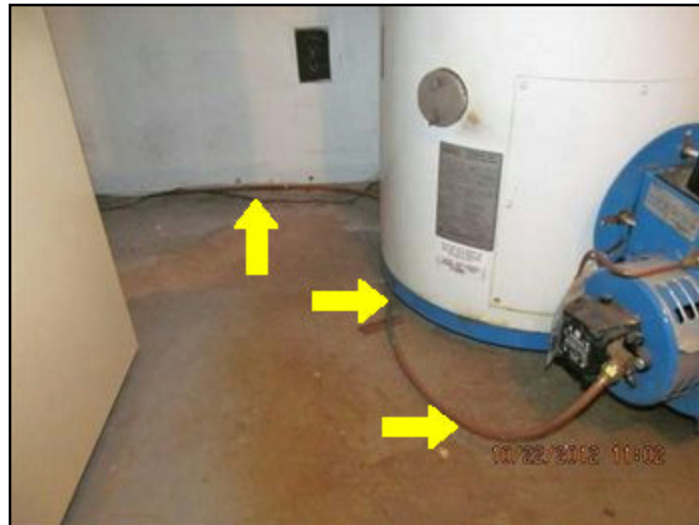
Fuel line not vinyl coated

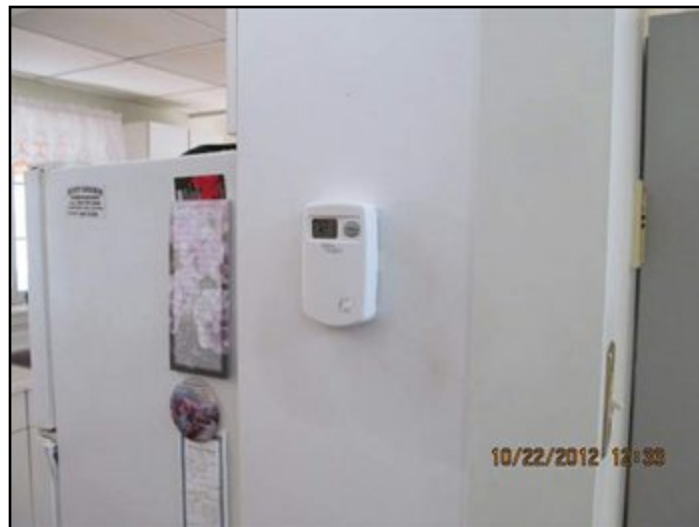
Existing oil furnace thermostat

Task: Upgrade

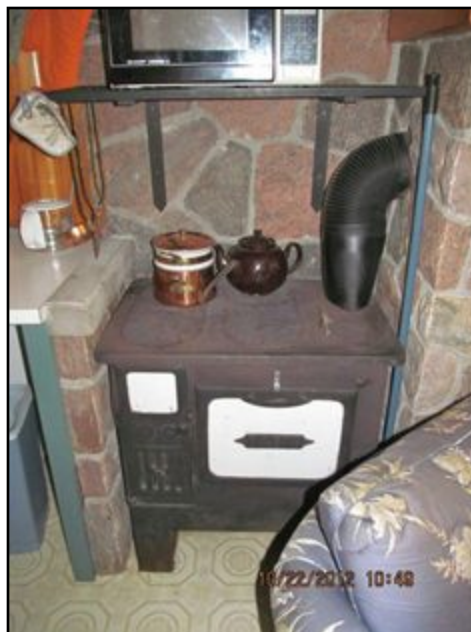
Uncertified cook stove

Task: Remove

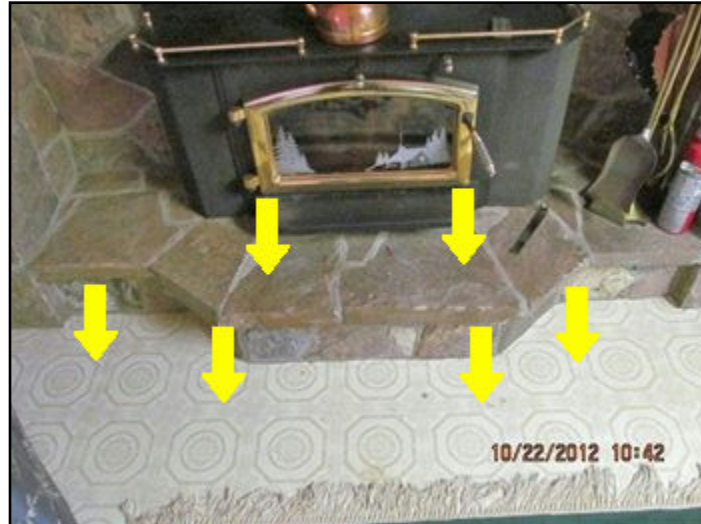
Hearth too small

Task: Correct

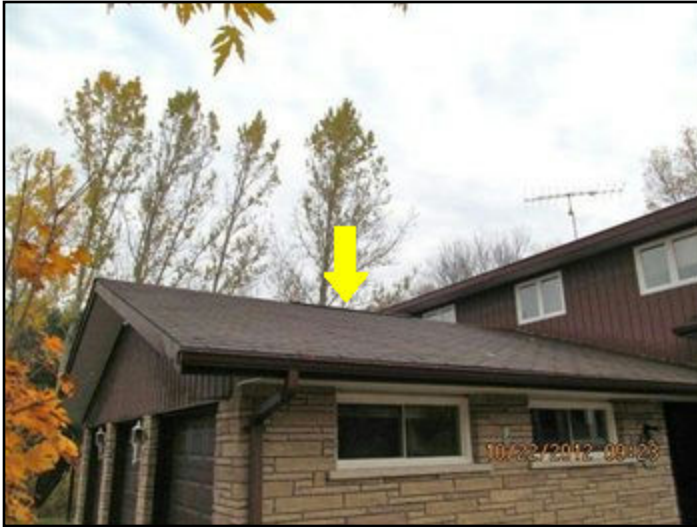
Not large enough ridge vent on garage

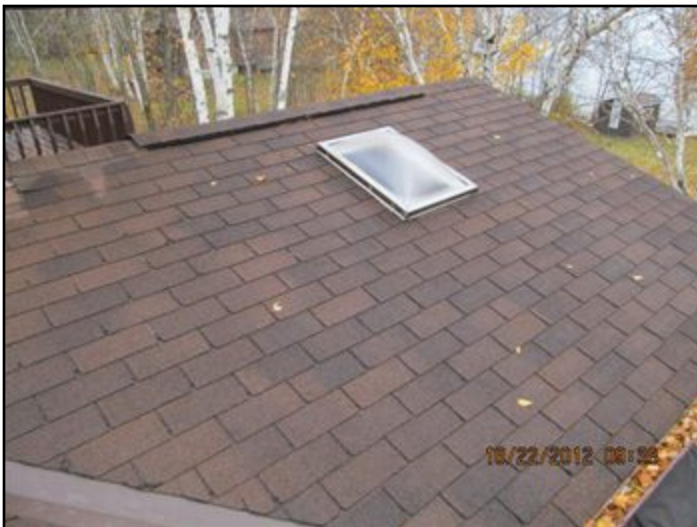
Ridge vent not long enough

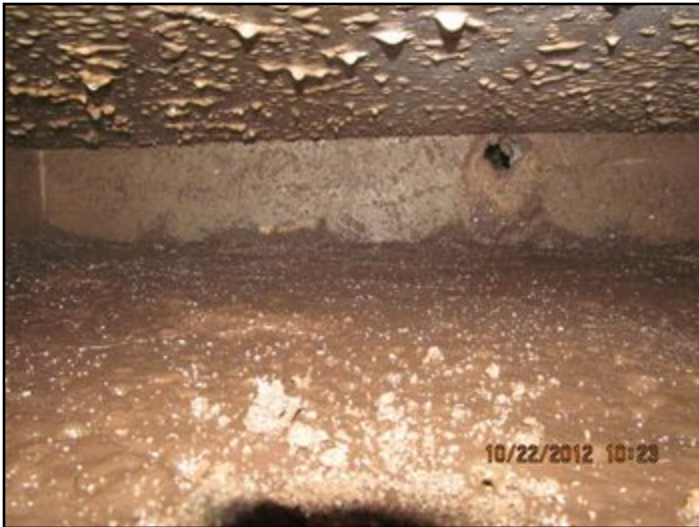
View of interior baffle

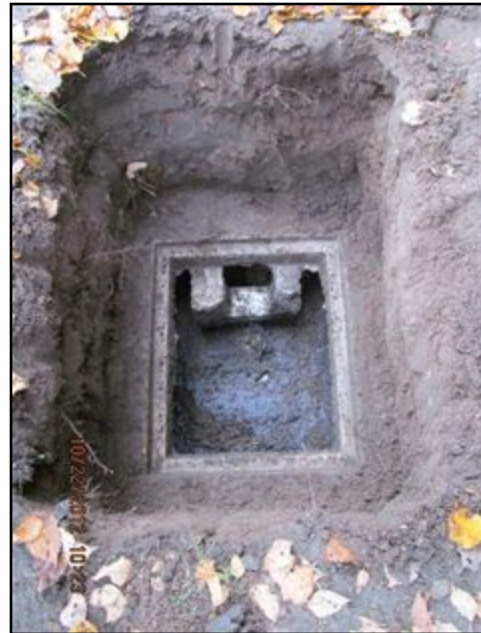
View of inlet chamber

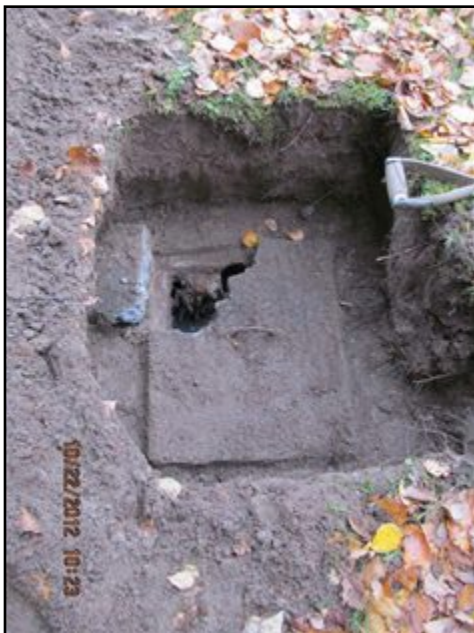
View of outlet chamber

• Outlet baffle has deteriorated to the point that it has to be replaced. To replace baffle the tank will have to be pumped out.

Pump out septic tank next spring and have outlet baffle replaced.

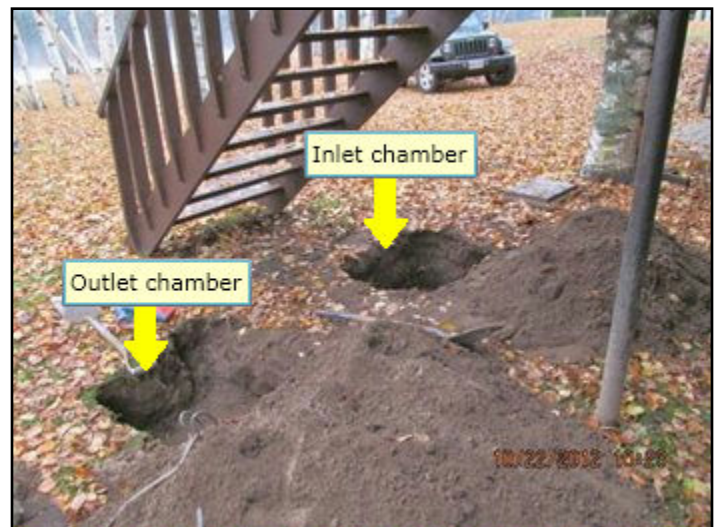
Location of septic tank

- Septic tank is actually too small for current number of 5 bedrooms and two kitchens. The problem being that when all bedrooms are occupied (10) people then the septic tank will not have time for solids to settle and there is a chance of scum getting into outlet chamber and flowing out to leaching bed, with chance of clogging leaching bed.
- Visually inspect septic tank every couple of years. Check to see if pump out needed and monitor condition of outlet chamber. Wash outlet chamber and baffle area with clean water from hose.

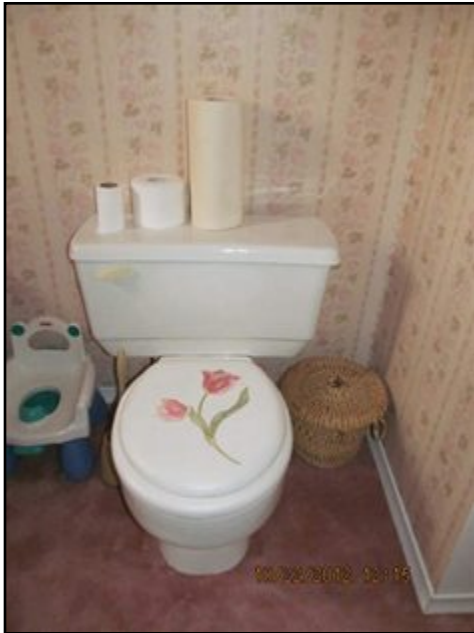
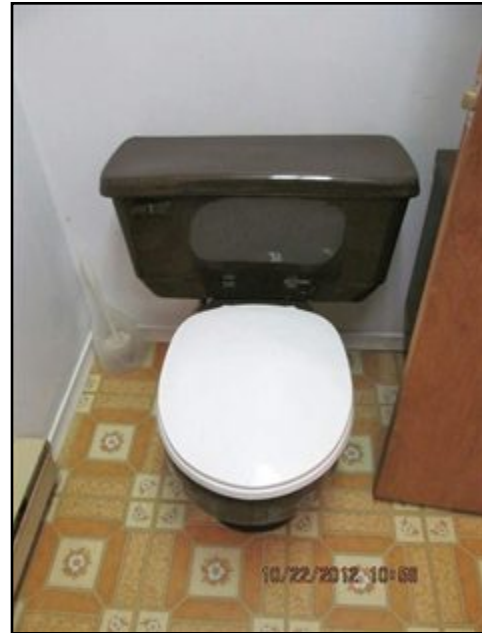
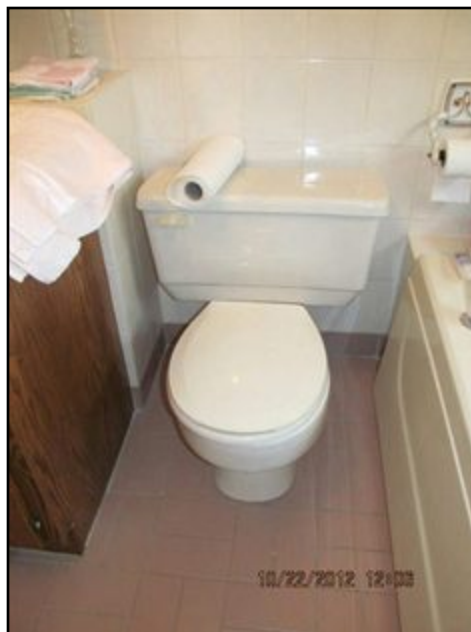
Condition: • Replace toilet with a duo-flush (3 litre/6 litre) to put less water into septic system.

High volume toilet

Task: Upgrade

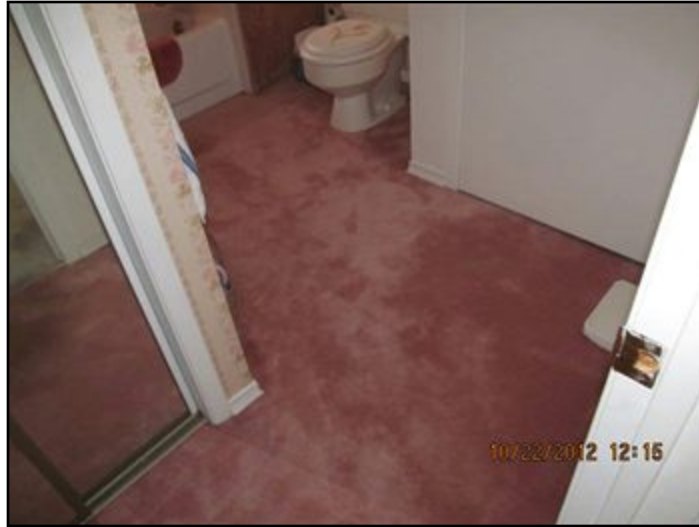
Condition: • [Squeaks](#)

Squeaky bathroom floor

Task: Repair
